**MELODY LANE SW**  
**SIDEWALK STUDY**  
TOWN OF VIENNA  
FAIRFAX COUNTY, VIRGINIA

SHEET  
1  
OF  
4

FILE No.  
RP-2530

TREE INVENTORY AND CONDITION ANALYSIS  
MELODY LANE SW  
SIDEWALK STUDY  
TOWN OF VIENNA  
FAIRFAX COUNTY, VIRGINIA  
C.I. N/A

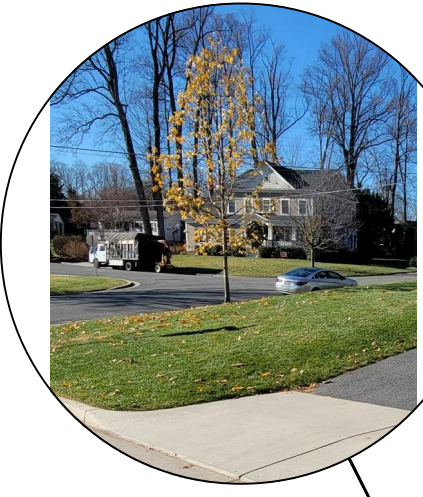
4" SWEETGUM IN EXCELLENT CONDITION.

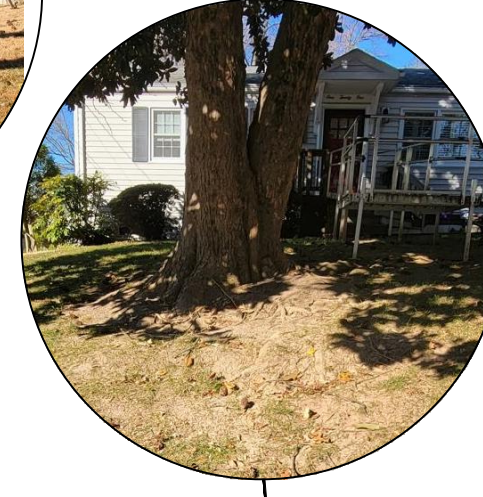
36" SOUTHERN MAGNOLIA IN GOOD CONDITION. TREE IS ON SLOPE. GRADING MAY AFFECT CRITICAL ROOT ZONE.

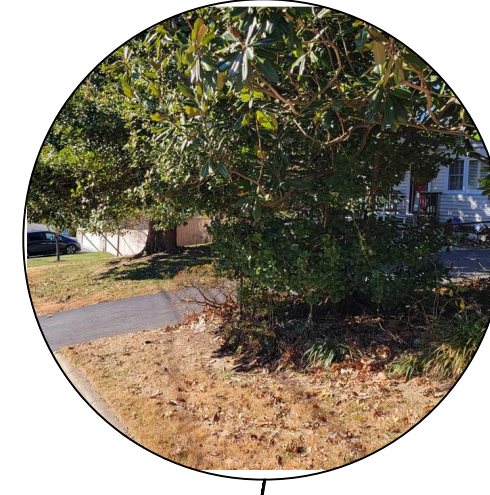
18" MULTI-TRUNK AMERICAN HOLLY IN GOOD CONDITION. CRITICAL ROOT ZONE MAY BE AFFECTED BY GRADING.

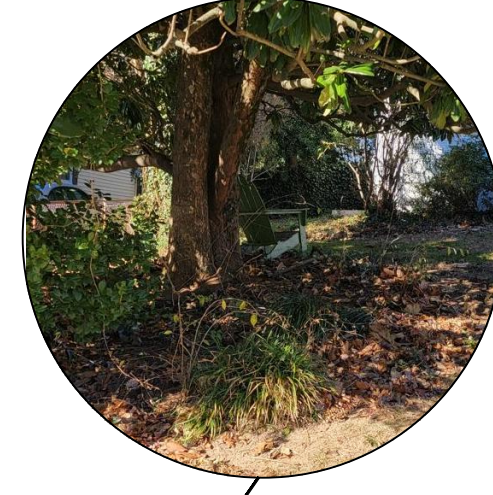
28" SOUTHERN MAGNOLIA IN GOOD CONDITION. CRITICAL ROOT ZONE MAY BE AFFECTED.

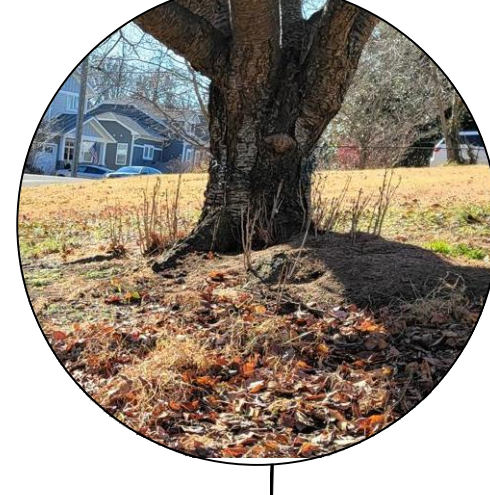
26" YOSHINO CHERRY AT EXCELLENT CONDITION. LOW BRANCHES OVERHANG STREET. TREE WOULD HAVE TO LIMBED UP. CRITICAL ROOT ZONE OF TREE WOULD BE AFFECTED.

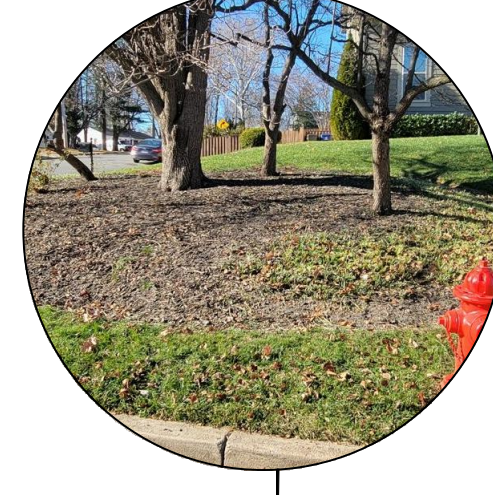
20" BRADFORD PEAR IN GOOD CONDITION. TREE EXHIBITS STRESS GROWTH. CRITICAL ROOT ZONE OF TREE WOULD BE AFFECTED.

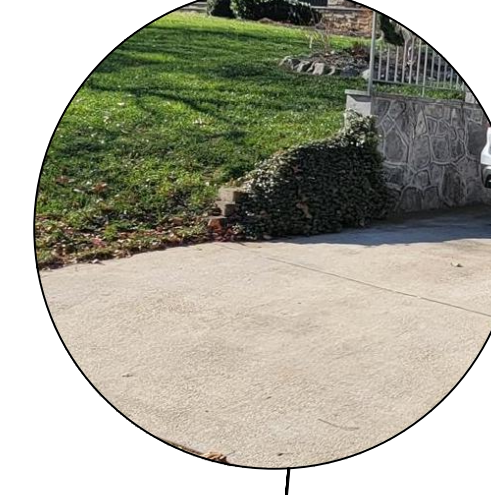
SIDEWALK WILL BE ON SLOPE AND GRADING HAS TO BE MAINTAINED PROPOSING RETAINING WALL AS NEEDED.

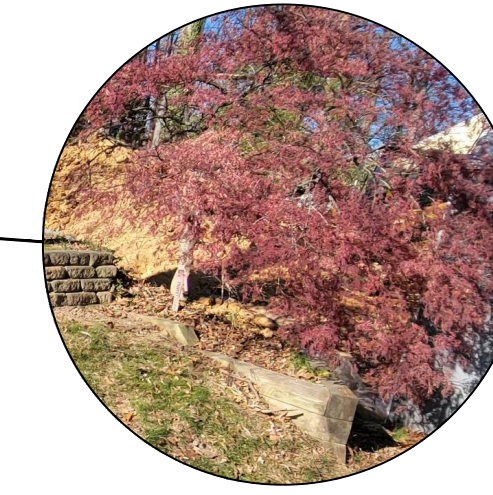
4" WEeping JAPANESE MAPLE IN EXCELLENT CONDITION. IN PATH OF SIDEWALK. TREE WOULD HAVE TO BE REMOVED.

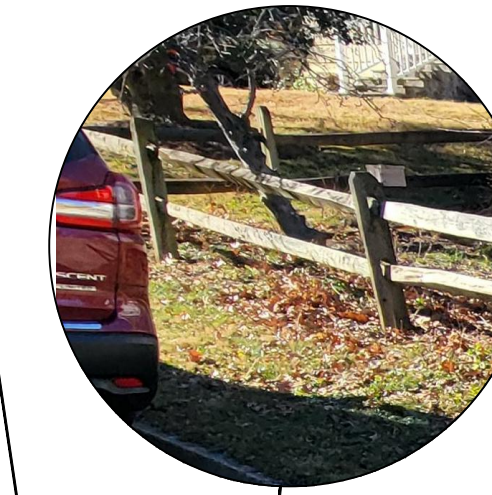
8" UNKNOWN DWARF TREE IN FAIR CONDITION. CRACKED BARK. HEAVY PRUNING. IMPACT TO CRITICAL ROOT ZONE OF TREE. TREE TO BE REMOVED.

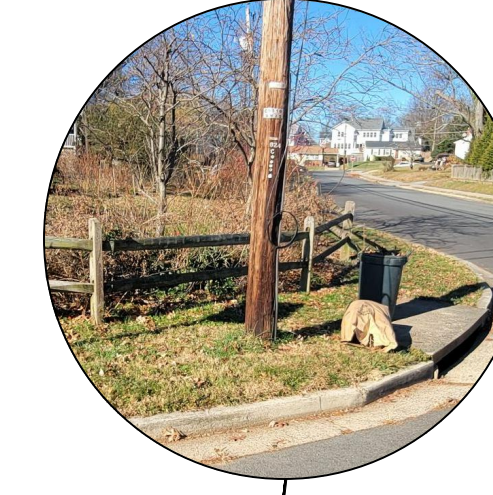
EX. ELECTRIC POLE ON THE WAY OF SIDEWALK. POLE LIKELY NEEDS TO BE RELOCATED.

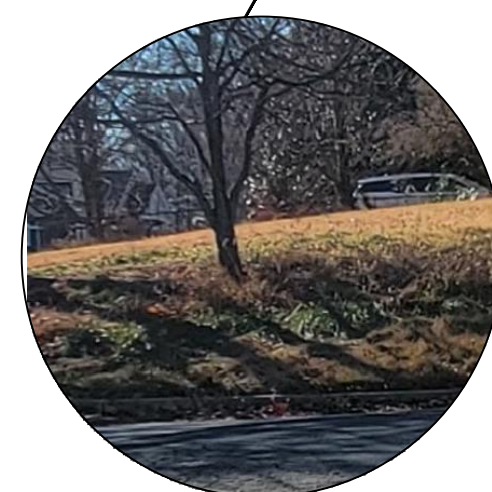
20" RED MAPLE IN GOOD CONDITION. BRANCHES OVERHANGING STREET WOULD NEED TO BE LIMBED UP. TREE CRITICAL ROOT ZONE WOULD BE SIGNIFICANTLY AFFECTED.

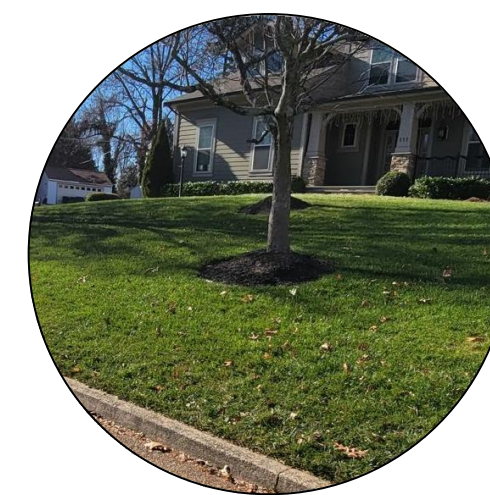
6" FLOWERING DOGWOOD IN GOOD CONDITION. GRADING WILL IMPACT.

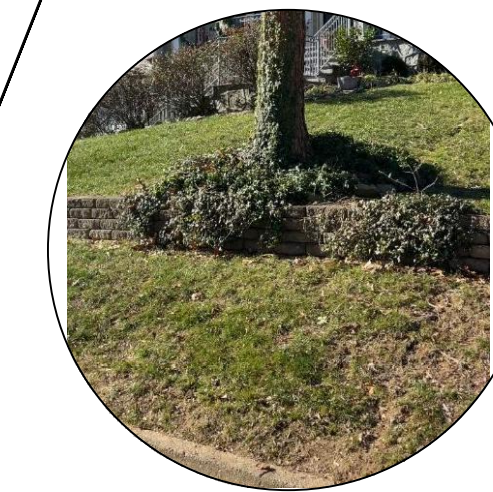
10" FLOWERING DOGWOOD IN FAIR CONDITION. ON SLOPE, CRITICAL AND STRUCTURAL ROOT ZONE WILL BE IMPACTED BY GRADING. LOW BRANCHES WOULD NEED TO BE LIMBED UP.

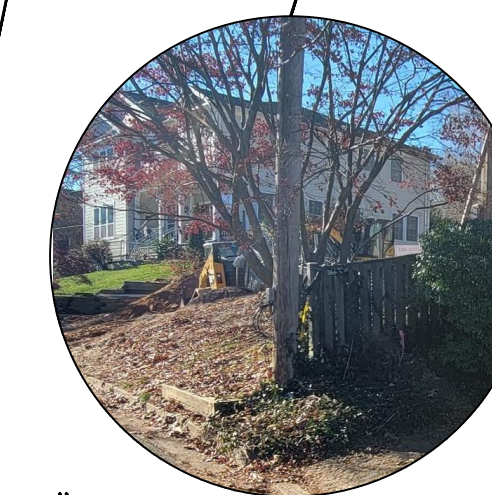
16" RIVER BIRCH IN GOOD CONDITION. CO-DOMINANT. ON SLOPE, GRADING MAY IMPACT CRITICAL ROOT ZONE AND STRUCTURAL ROOT ZONE. TREE NEEDS TO BE REMOVED.

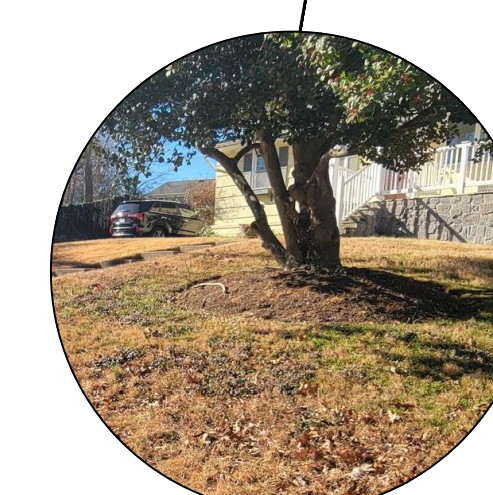
12" JAPANESE MAPLE IN GOOD CONDITION. IN PATH OF SIDEWALK. TREE NEEDS TO BE REMOVED.

RETAINING WALL NEEDS TO BE REMOVED AND ADJUSTED AT THE BACK OF PROPOSED SIDE WALK. EX. ELECTRIC POLE NEEDS TO BE RELOCATED.

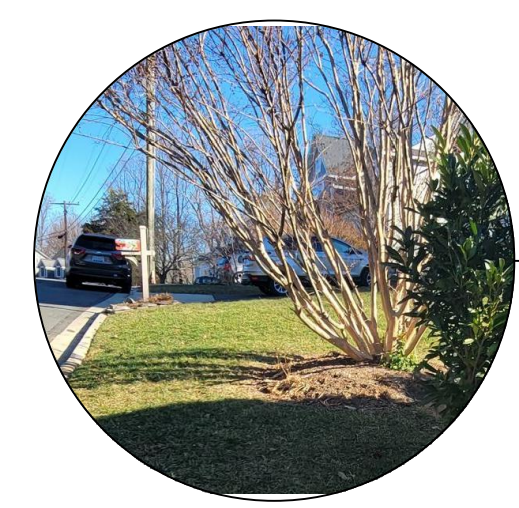
18" MULTI-STEM CRAPE MYRTLE WITH LOW BRANCHES WHICH WILL NEED TO BE PRUNED. GRADING IN CRITICAL ROOT ZONE WILL SIGNIFICANTLY IMPACT TREE.

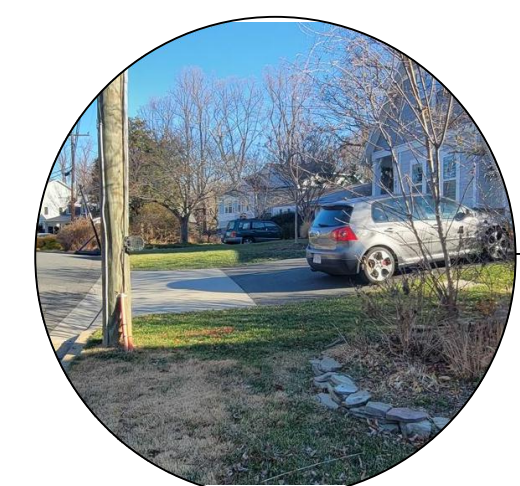
ELECTRIC POLE WITH GUY WIRE, ADJUST SIDEWALK WIDTH AS NECESSARY.

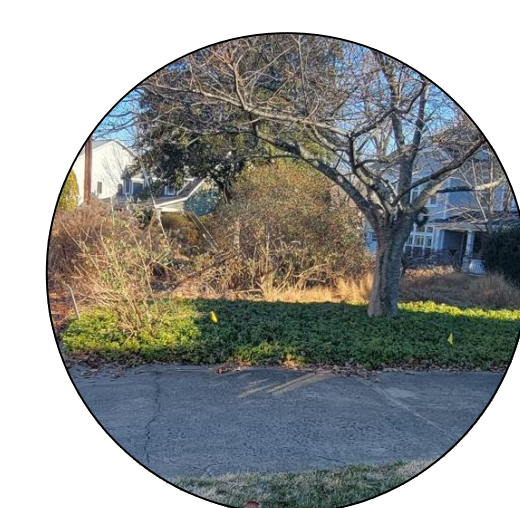
16" YOSHINO CHERRY IN EXCELLENT CONDITION. GRADING IN CRITICAL ROOT ZONE MAY IMPACT TREE.

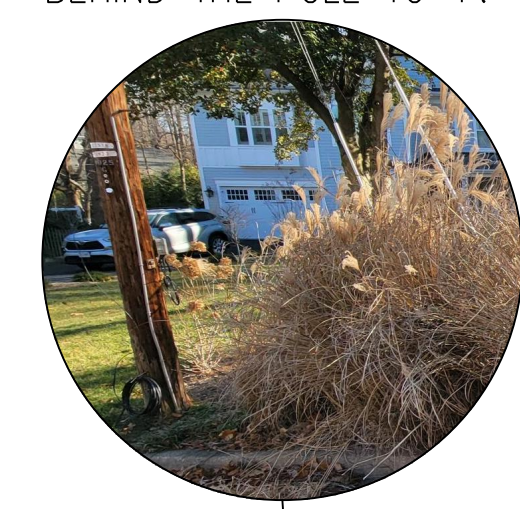
EX. ELECTRIC POLE IN THE WAY OF SIDEWALK. GUY WIRE NEEDS TO BE ADJUSTED. REDUCE SIDEWALK WIDTH BEHIND THE POLE TO 4'.

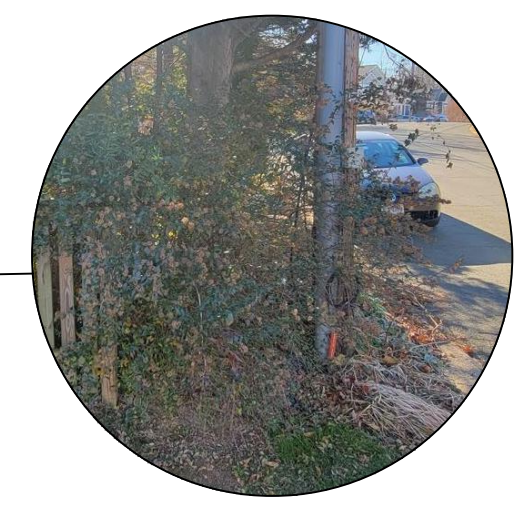
EX. ELECTRIC POLE IN THE WAY OF SIDEWALK. ADJUST SIDEWALK TO BE BEHIND THE POLE WITH MINIMUM SIDEWALK WIDTH OF 4'.

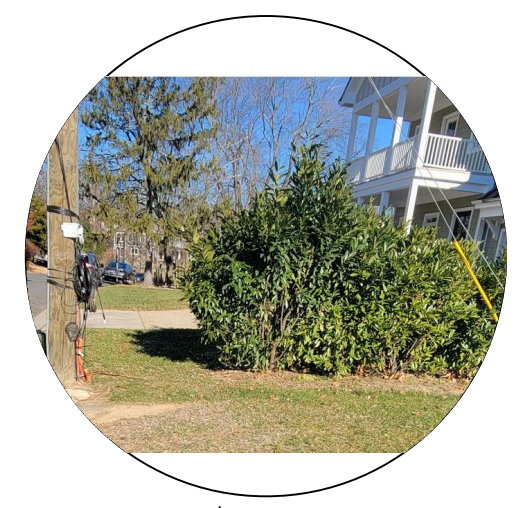
EX. ELECTRIC POLE IN THE WAY OF SIDEWALK. ADJUST SIDEWALK TO BE BEHIND THE POLE WITH MINIMUM SIDEWALK WIDTH OF 4'.

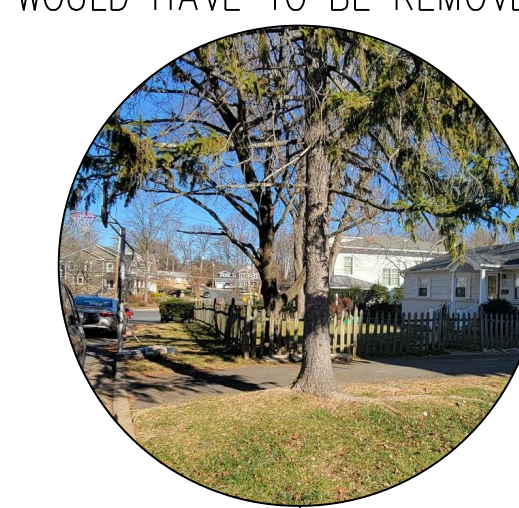
16" NORWAY SPRUCE IN FAIR CONDITION WITH THIN CANOPY AND DECLINING HEALTH. SEVERE IMPACT CRITICAL AND STRUCTURAL ROOT ZONE. TREE WOULD HAVE TO BE REMOVED.

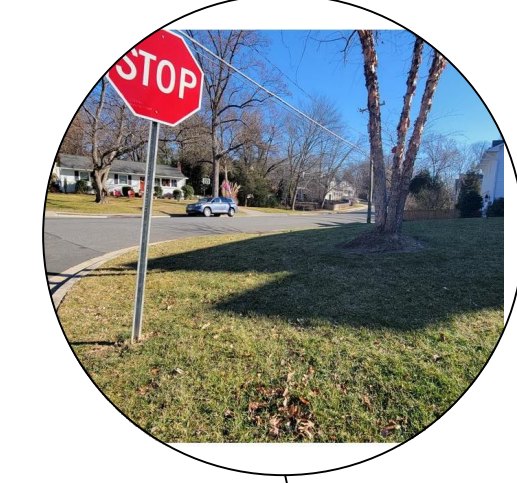
16" MULTI STEM RIVER BIRCH IN FAIR CONDITION. SEVERELY TOPPED.

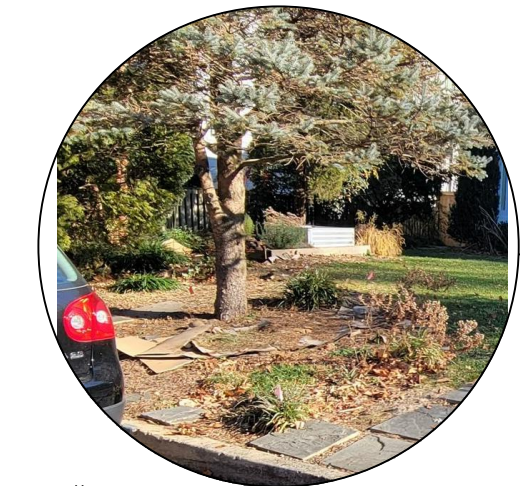
14" BLUE SPRUCE IN FAIR CONDITION. NEEDLE LOSS, TREE IS DECLINING. IN THE PATH OF SIDEWALK. TREE HAVE TO BE REMOVED.

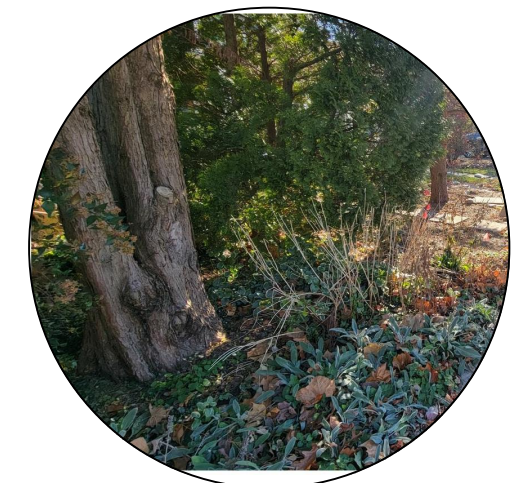
18" LEYLAND CYPRESS IN FAIR CONDITION. CO-DOMINANT, SEVERELY TOPPED FROM PRUNING FOR OVERHEAD WIRES. IN PATH OF THE SIDEWALK. TREE NEEDS TO BE REMOVED.

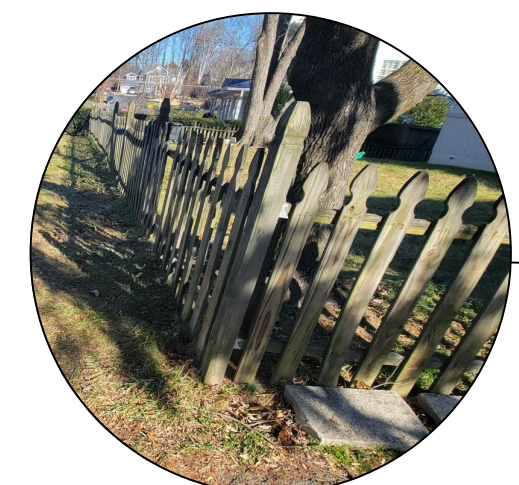
18" RED MAPLE IN POOR CONDITION WITH GIRDLING BRANCHES. MANY DEAD BRANCHES. SIGNIFICANT IMPACT TO STRUCTURAL AND CRITICAL ROOT ZONE. TREE PROBABLY WOULD NOT SURVIVE. TREE TO BE REMOVED.
