FILE No. RP-2532

ANALYSIS OF CONCEPT 1- TAZEWELL RD NW

TREE INVENTORY & CONDITION ANALYSIS

TAZEWELL ROAD NW
SIDEWALK STUDY
TOWN OF VIENNA
FAIRFAX COUNTY, VIRGINIA

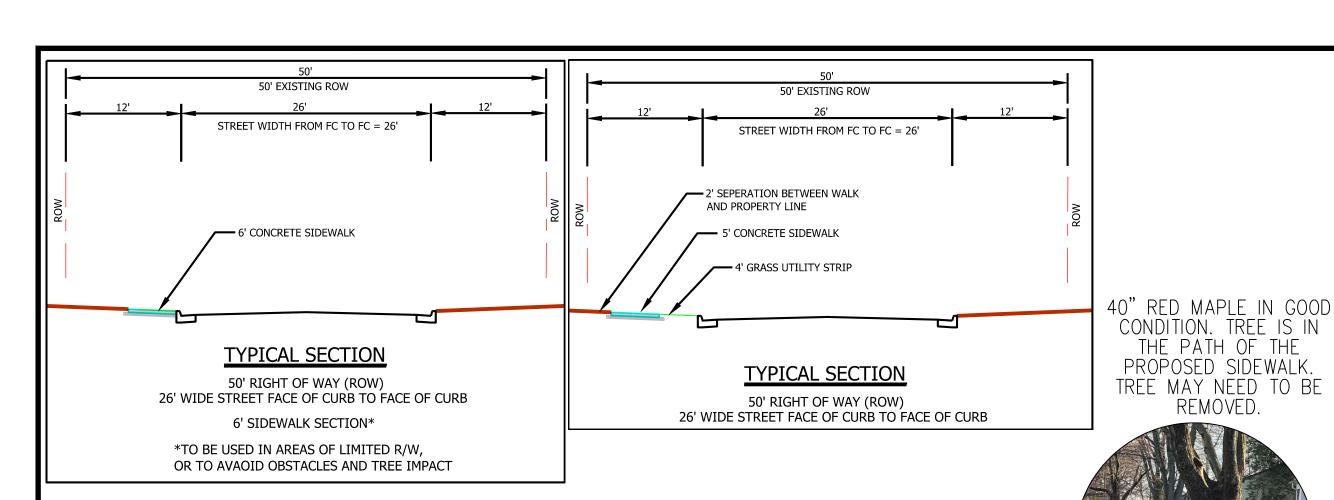
21" RED MAPLE IN POOR CONDITION. ONE THIRD OF TREE BROKEN AND SIGNIFICANT STRUCTURAL DECAY. TREE MAY NEED TO BE REMOVED.

CONDITION. SURFACE ROOTS EXPOSED. SOME OF THE CRITICAL ROOT ZONE WILL IN BETWEEN POLE AND EX. BE AFFECTED BY POTENTIAL

36" RED MAPLE IN GOOD

CONDITION. TOP BROKEN OFF, GRADING FOR SIDE CRITICAL ROTE ZONE

28" NORWAY SPRUCE IN MAY IMPACT CRITICAL ROOT ZONE. SIDEWALK TO BACK OF CURB.

14" FLOWERING DOGWOOD IN FAIR CONDITION. CO-DOMINANT. DECAY/DAMAGE ON TRUNK.

14" SAUCER MAGNOLIA IN GOOD CONDITION. Y-CROTCH, GRADING MAY IMPACT CRITICAL ROOT ZONE. SIDEWALK TO BE PROPOSED AT THE BACK OF

TWO 5" CRAPE MYRTLE IN EXCELLENT CONDITION. MULTI-TRUNK, NEWLY PLANTED TREE IN PATH OF SIDEWALK. POSSIBLE TRANSPLANT.

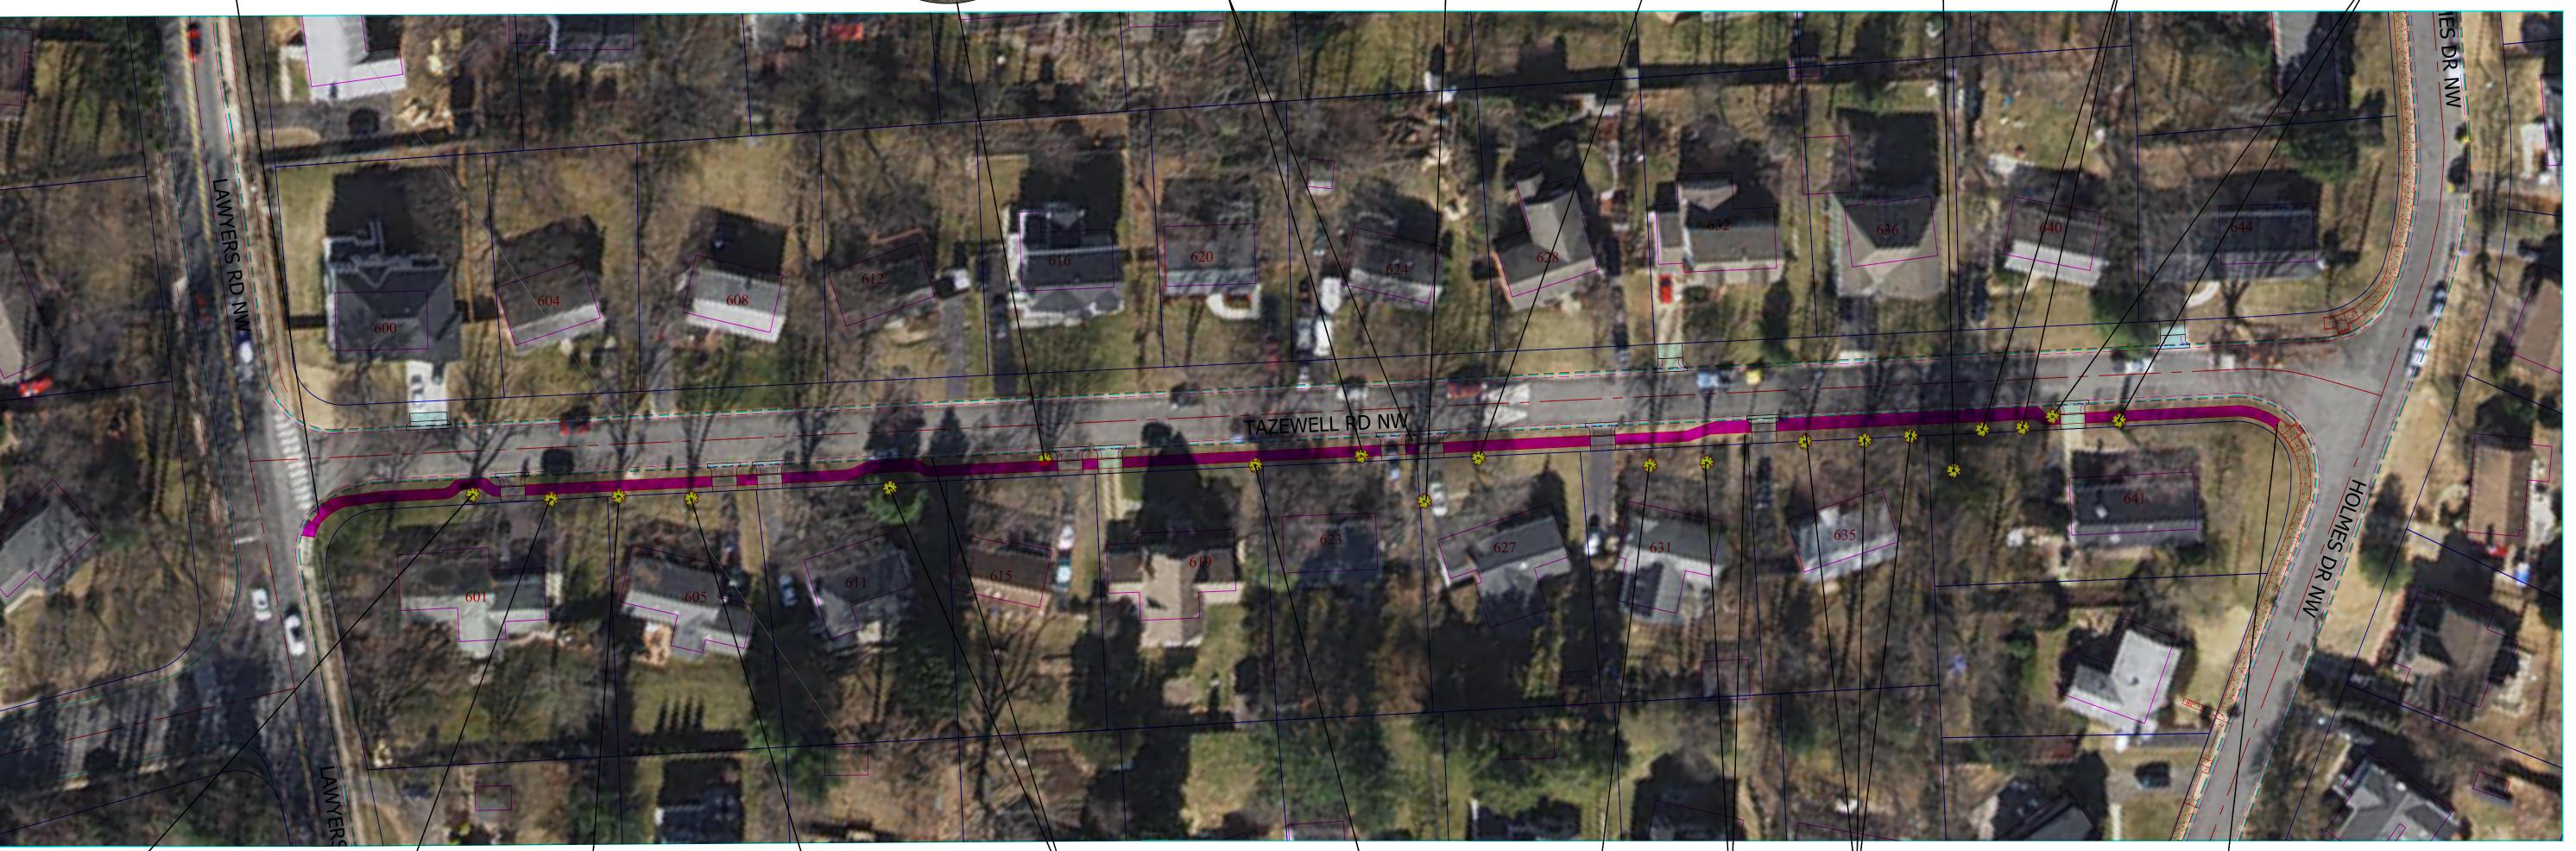
CONCEPT 1

EX. 38" RED MAPLE IN FAIR CONDITION WITH SURROUNDED BY RETAINING WALL TOWARDS FRONT SIDE. TREE TRUNK DECAY, BRANCH DIEBACK. GRADING MAY IMPACT CRITICAL ROOT ZONE. SIDEWALK TO BE PROPOSED AT THE BACK OF CURB AND RETAINING WALL TO BE PROPOSED AROUND THE TREE.

8" FLOWERING MULTI-STEM DOGWOOD IN FAIR CONDITION. TREE MAY BE AFFECTED BY THE GRADING FOR SIDEWALK

EX. 40" RED MAPLE IN GOOD CONDITION. SOME BRANCHES ARE MISSING. GRADING FROM PROPOSED SIDEWALK WILL AFFECT THE CRITICAL ROOT ZONE

EX. 38" RED MAPLE IN GOOD CONDITION. SOME DIEBACK, GRADING FROM SIDEWALK MAY AFFECT CRITICAL ROOT ZONE. ONE THIRD OF TRUNK MISSING.

EX. 12" SAUCER MAGNOLIA IN EXCELLENT CONDITION. GRADING FROM POTENTIAL WALK WILL AFFECT CRITICAL ROOT ZONE. SIDEWALK TO BE PROPOSED AT THE BACK OF CURB TO MINIMIZE THE TREE IMPACT.

30" RED MAPLE IN GOOD CONDITION.
LARGE BROKEN
BRANCHES, SURFACE ROOTS EXPOSED.

16" RED MAPLE IN GOOD CONDITION. SIDEWALK GRADING MAY AFFECT CRITICAL ROOT ZONE.

EX. UTILITY POLE AT THE PATH
OF POTENTIAL SIDEWALK. SIDEWALK TO BE PROPOSED AT THE BACK OF CURB.

38" RED MAPLE IN FAIR CONDITION. CO-DOMINANT. SURFACE ROOTS EXPOSED AND SOME TRUNK DECAY.

ALL TREES ARE IN A SLOPE AND GRADING MAY IMPACT CRITICAL ROOT ZONE. SIDEWALK TO BE PROPOSED AT THE BACK OF CURB.

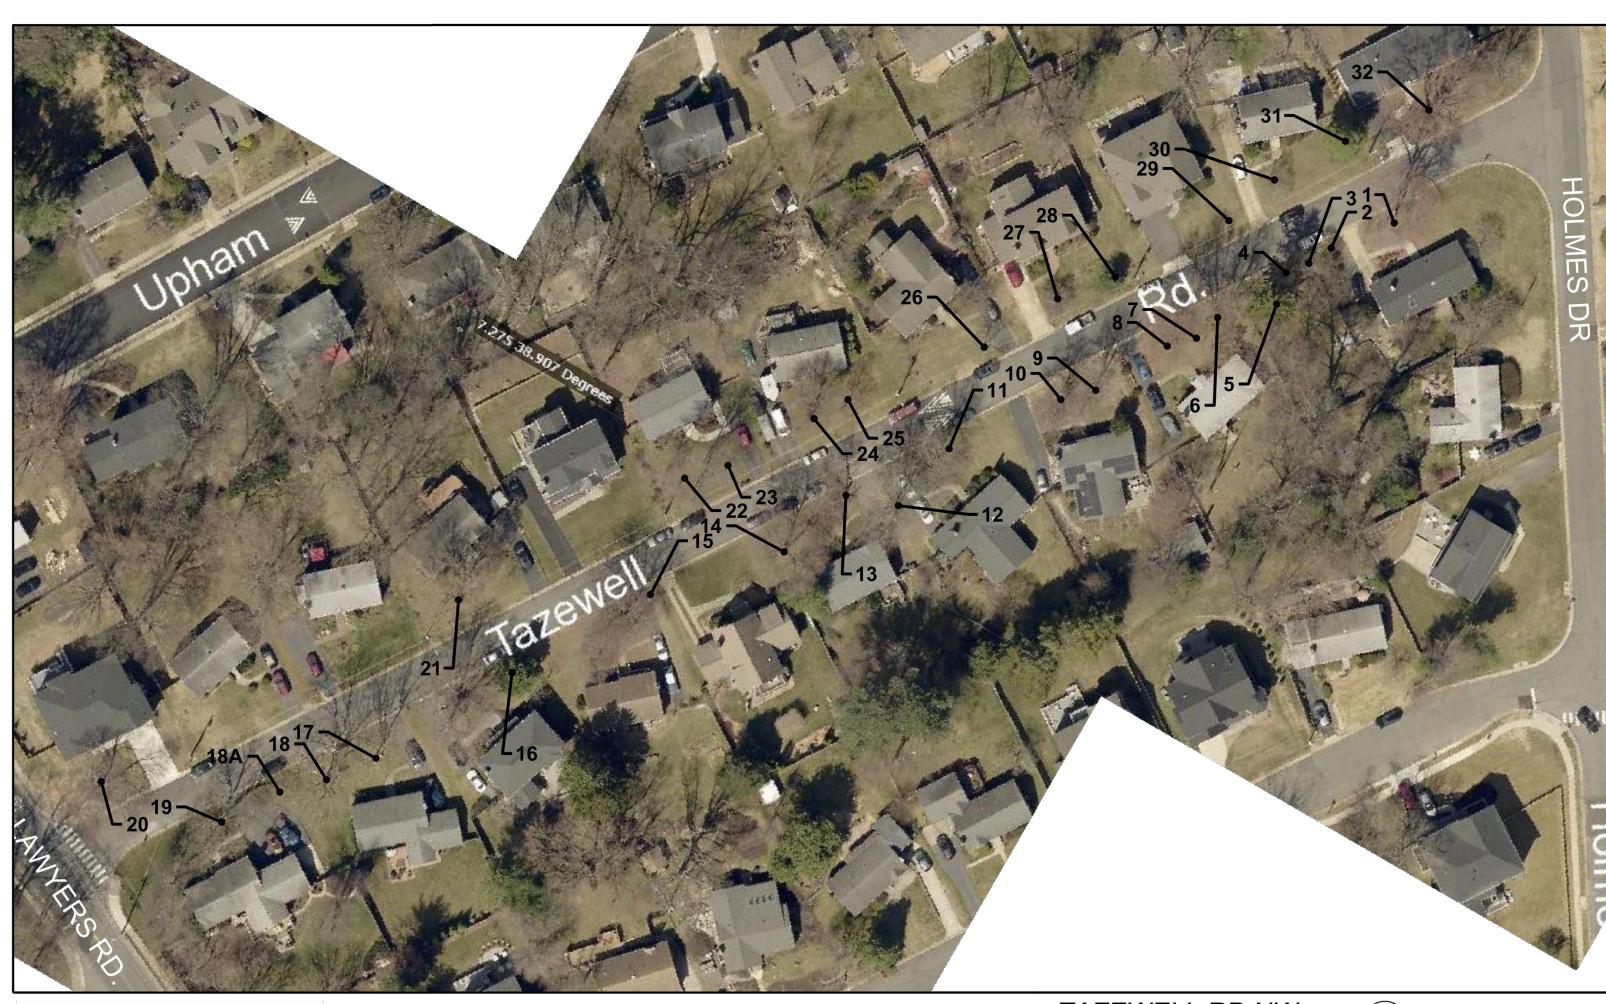
TREE LOCATIONS FOR INVENTORY BY URBAN - LTD 01/19/2022

TREE NO.	SPECIES		SIZE	DRIP- LINE	CRITICAL ROOT ZONE	STRUCTURAL ROOT ZONE	CONDITION	CONDITION RATING	STATUS	COMMENTS
	Botanical Name	Common Name	DBH (in)	R (ft.)	R (ft.)	R (ft.)		%	(Remove or Preserve)	
1	Lagerstroemia indica	Crape Myrtle	5"	3'	5'	2'	Excellent	90.63		Multi-trunk; newly planted. In path of walk; Possible transplant
2	Lagerstroemia indica	Crape Myrtle	5"	3'	5'	2'	Excellent	90.63		Multi-trunk; newly planted. In path of walk; Possible transplant
3	Cornus florida	Flowering Dogwood	14"	8'	14'	7'	Fair	46.88		Co-dominant; Decay/damage on trunk
4	Magnolia soulangeana	Saucer Magnolia	14"	11'	14'	7'	Good	75.00		Y-crotch; grading may impact critical root zone. Recommend walk at back o curb.
5	Picea abies	Norway Spruce	28"	14'	28'	14'	Good	68.75		Surface roots exposed; grading may impact critical root zone. Recommend walk at back of curb.
6	Acer rubrum	Red Maple	38"	16'	38'	19'	Fair	59.38		Co-dominant; Surface roots exposed; Some trunk decay

7	Cornus florida	Flowering Dogwood	8"	6'	8'	4'	Fair	53.13		Co-dominant
8	Acer rubrum	Red Maple	20"	18'	20'	10'	Good	71.88		
9	Acer rubrum	Red Maple	16"	12'	16'	8'	Good	71.88		Grading for walk will affect critical root zone of tree.
10	Acer rubrum	Red Maple	15"	14'	15'	8'	Good	65.63		
11	Acer rubrum	Red Maple	17"	14'	17'	9'	Good	68.75		Top broken off; Grading for walk will affect critical root zone of tree.
12	Acer rubrum	Red Maple	36"	26'	36'	18'	Good	75.00		Surface roots exposed; Some of the critical root zone will be affected by potential walk.
13	Acer rubrum	Red Maple	21"	18'	21'	11'	Poor	37.50		1/3 of tree broken off; significant structural decay
14	Acer rubrum	Red Maple	30"	26'	30'	15'	Good	65.63		Large broken branches; Surface roots exposed
15	Acer rubrum	Red Maple	40"	24'	40'	20'	Good	62.50		Tree is close to curb; in path of potential walk
16	Magnolia soulangeana	Saucer Magnolia	12"	12'	12'	6'	Excellent	81.25		Grading from potential walk will affect critical root zone.

17	Acer rubrum	Red Maple	38"	24'	38'	19'	Good	62.50		Some-dieback, Grading from potential walk will affect critical root zone; 1/3 of trunk missing
18	Acer rubrum	Red Maple	40"	26'	40'	20'	Good	68.75		Some branches missing; Grading from potential walk will affect critical root zone.

TREE NO.	SPECIES		SIZE	DRIP- LINE	CRITICAL ROOT ZONE	STRUCTURAL ROOT ZONE	CONDITION	CONDITION RATING	STATUS	COMMENTS
	Botanical Name	Common Name	DBH (in)	R (ft.)	R (ft.)	R (ft.)		%	(Remove or Preserve)	
18A	Cornus Florida	Flowering Dogwood	8"	5'	8'	4'	Fair	56.25		Multi-stem; Tree likely to be affected by grading for sidewalk
19	Acer rubrum	Red Maple	38"	25'	38'	19'	Fair	50.00		Trunk decay; Branch dieback; Grading from potential walk will affect critical root zone. Tree is surrounded by timber retaining wall
20	Acer rubrum	Red Maple	26"	20'	26'	13'	Good	65.63		Critical root zonewill be affected by potential walk; Recommend walk be located at back of curb
21	Acer rubrum	Red Maple	20"	16'	20'	10'	Fair	59.38		Surface roots exposed; Heavy pruning for overhead wires on streetside
22	Acer rubrum	Red Maple	12"	14'	12'	6'	Fair	59.38		One-sided; Leaning; Far enough back from potential walk
23	Cornus florida	Flowering Dogwood	7"	12'	7'	4'	Good	62.50		Overhead wires in canopy; Close to potential walk

24	Acer rubrum	Red Maple	34"	18'	34'	17'	Fair	46.88		Large portions missing; Decay
25	Acer rubrum	Red Maple	20"	10'	20'	10'	Poor	31.25		Broken off @ 12'; Significant decay in trunk; trunk is split on one side.
26	Cornus florida	Flowering Dogwood	10"	12'	10'	5'	Fair	53.13		Overhead wires in canopy; Heavily pruned; Close to potential walk location
27	Magnolia stellata	Star Magnolia	18"	10'	18'	9'	Good	68.75		Multi-trunk.
28	llex opaca	American Holly	9"	7'	9'	5'	Good	75.00		Recommend walk be located at back of curb; Branches will need to be kept pruned; conflict with utility pole
29	Cornus kousa	Kousa Dogwood	2"	4'	2'	1'	Good	78.13		New young tree; Possible transplant
30	Cornus florida	Flowering Dogwood	12"	12'	12'	6'	Fair	59.38		Trunk decay; Grading will affect critical root zone of tree.
31	llex opaca	American Holly	16"	12'	16'	8'	Good	71.88		Up slope grading for walk will affect critical root zone of the tree.

32	Acer rubrum	Red Maple	40"	30'/15'	40'	20'	Fair	53.13		Rock retaining wall with fill around base of tree; Broken off branches. Tree has oval canopy. Grading into slope will significantly affect critical root zone.
