ELMAR ST SE/SW ENGINEERING REPORT
ROBINSON TRUST SIDEWALK PROGRAM

July 28, 2022

ELMAR DRIVE SE/SW
 Desale St to Park St

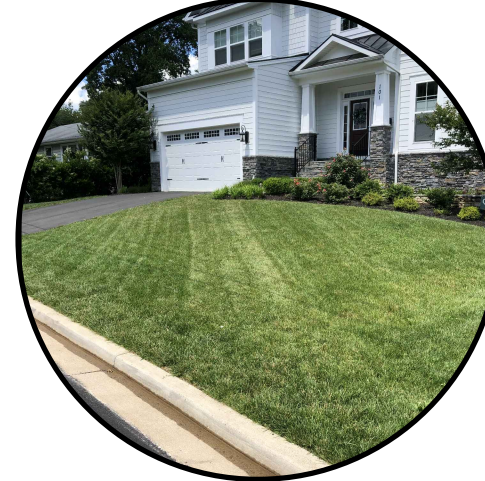
Photo along #101 Elmar- Clear path for sidewalk with minor grading required.

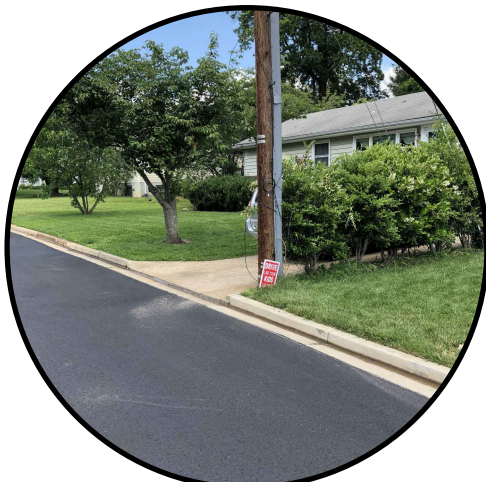
Sidewalk to be built at back of existing utility pole with 4' minimum clearance provided.

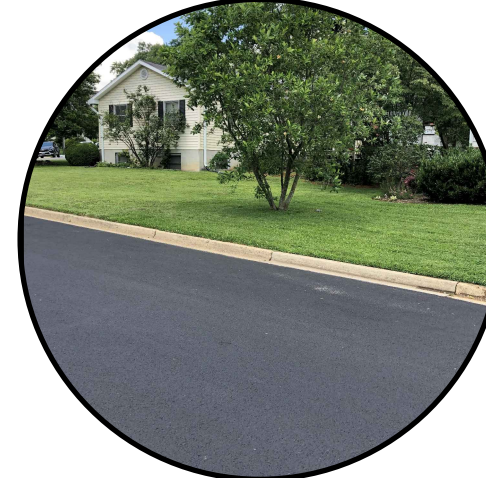
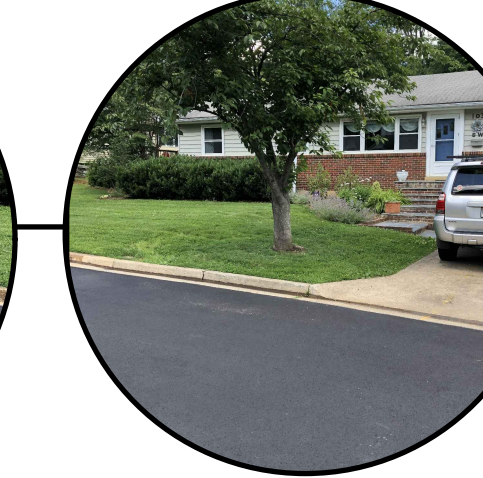
Photo along #103 Elmar- 14" Sweetbay Magnolia and 15" Yoshino Cherry to be removed by developer for new SFH construction.

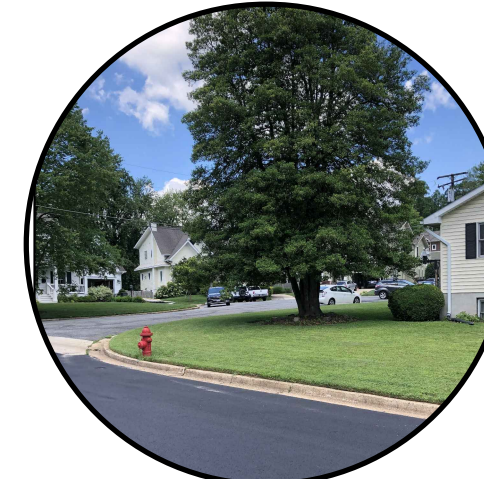
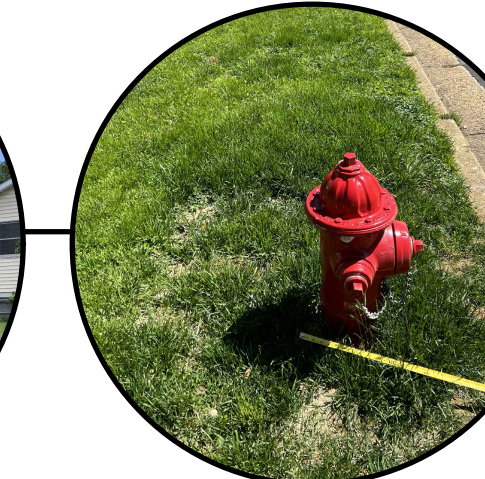
Photo along #1 Charles Circle. Curb return radii will be reduced to 25'. 40" American Holly in excellent condition will be preserved. Relocate fire hydrant close to curb to allow 4' clearance of sidewalk.

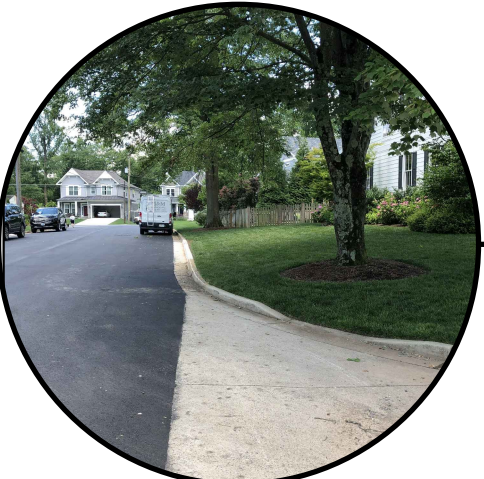
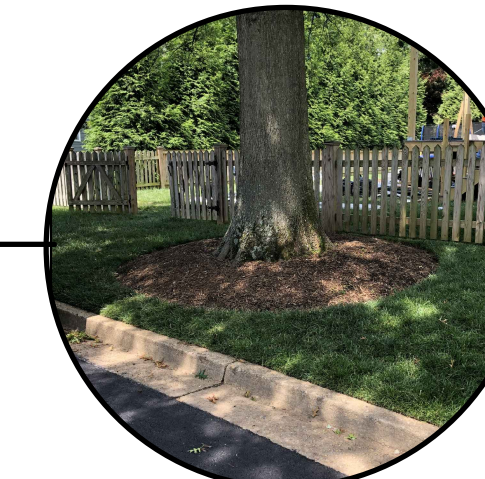
Photo along #6 Charles Circle. Bumping the curb out will preserve these trees. 25" Red Oak and 20" Red Maple.

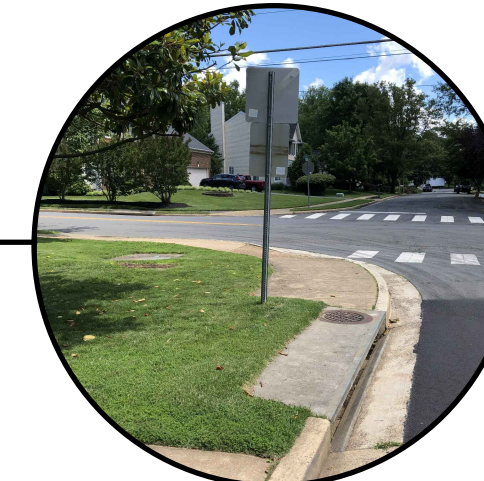
Connect new sidewalk to existing curb return at #118 Elmar. Provide new ADA ramps.

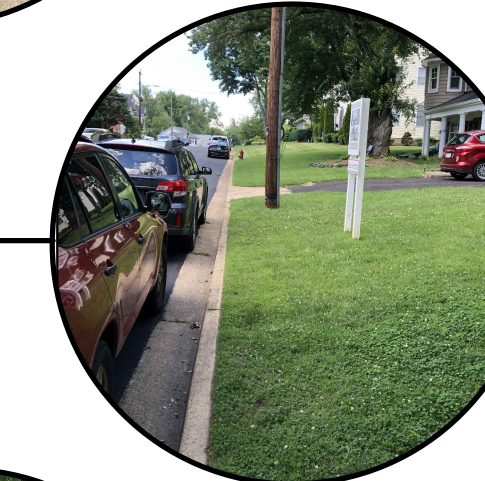
Existing utility pole between #114 & #116 Elmar Drive to be removed or relocated to allow minimum 4' clear width of sidewalk. This utility pole provides service lines to #114 and #116. TOV can request the utility companies to move the pole at their cost.

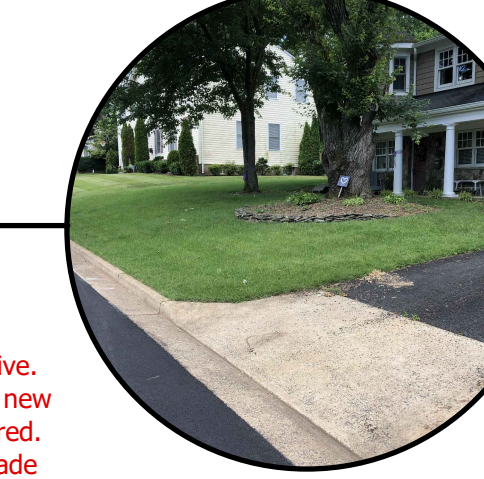
Photo at #114 Elmar Drive. Trees and tree border to be preserved.

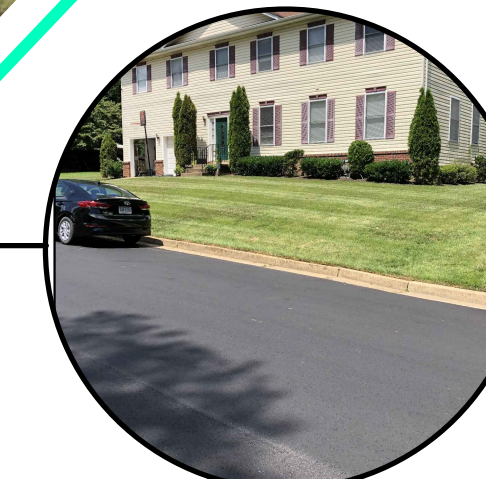
Photo at #112 Elmar Drive. Some grading between new sidewalk and yard required. Approximately 1 foot grade difference at back of new sidewalk.

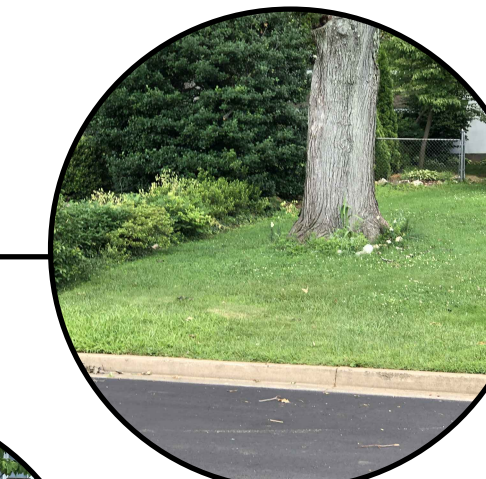
Photo at #108 Elmar Drive. 6" Flowering Dogwood to be preserved.

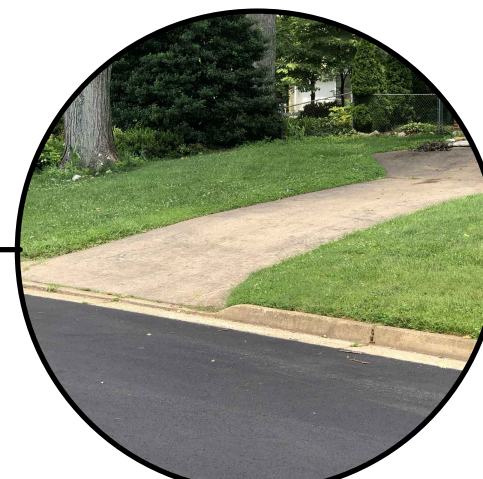
Photo at #110 Elmar Drive. 36" Red Maple to be preserved. Driveway to be rebuilt- see driveway profile. Excessive street crown to be improved by raising curb grade.

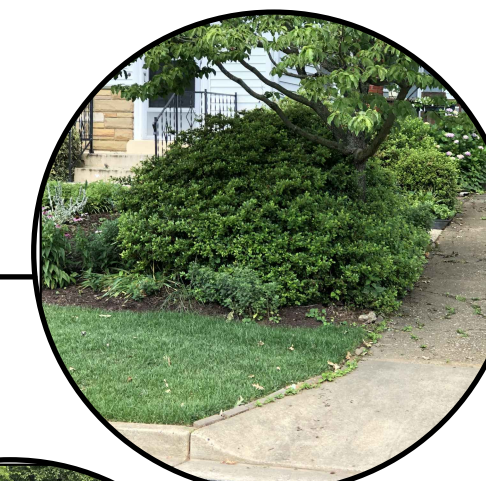
Photo at #106 Elmar Drive. Shrubs will need to be removed. Fence to remain, and mailbox to remain.

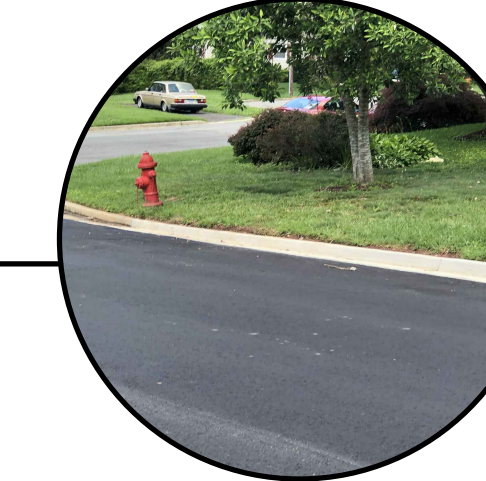
Photo along #6 Elaine Circle. Relocate fire hydrant close to curb to allow 4' clearance of sidewalk. 14" Sweetbay Magnolia will be preserved.

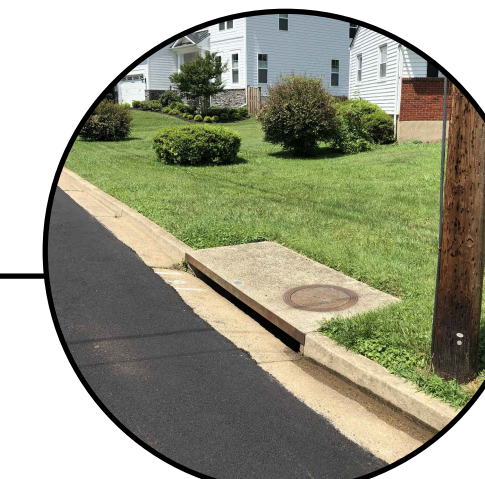
Photo at #1 Elaine Circle. Shrubs will need to be removed. Sidewalk to be built at back of existing utility pole with 4' minimum clearance provided.

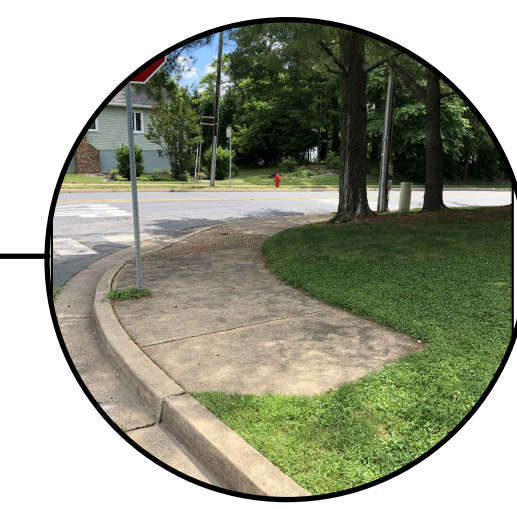
The new sidewalk will connect to existing sidewalk at Park Street. The curb return radii will be reduced to 25' and a current standard ADA ramp will be provided.

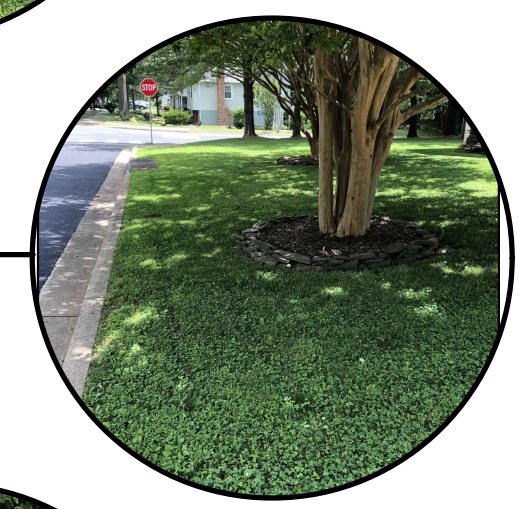
The sidewalk against the curb will be maintained across the frontage of #117 to preserve the existing trees (2- 30" Crepe Myrtles).

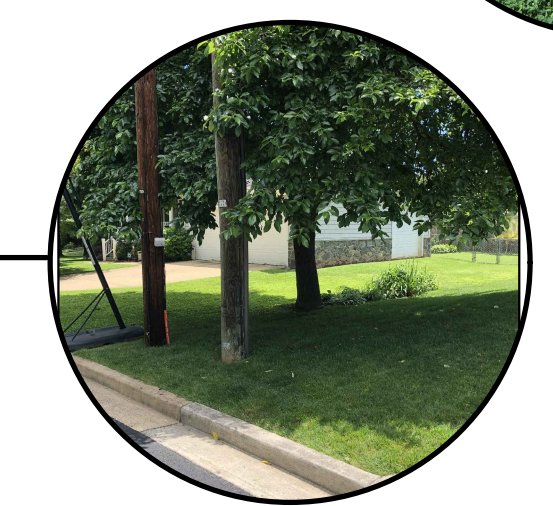
At the location of the 2 utility pole between #115 and #117 the sidewalk would be built adjacent to existing curb without utility strip. The 20" Black Gum Tree will be preserved.

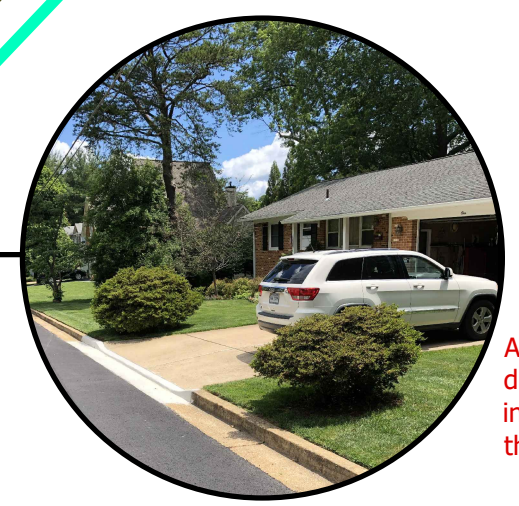
At #113 the shrubs on either side of the driveway and the 10" Flowering Dogwood are in the R/W and will need to be removed for the new sidewalk.

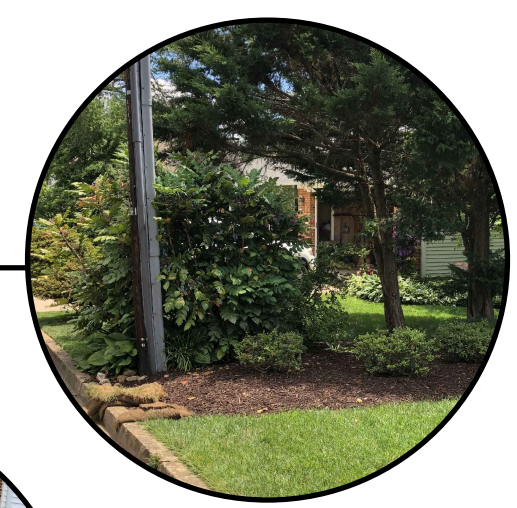
At the location of the utility pole between #111 and #113 the sidewalk would be built adjacent to existing curb without utility strip.

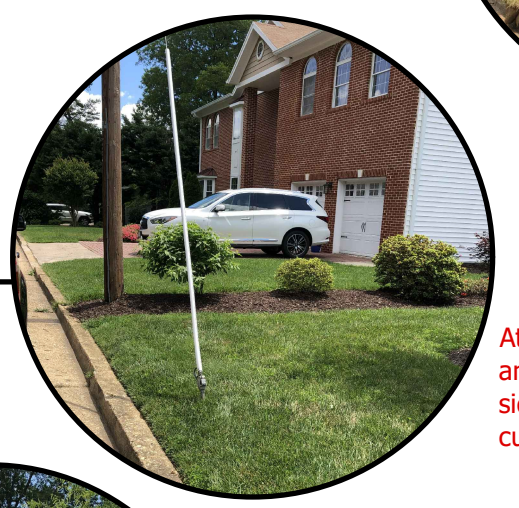
At the location of the utility pole and guy anchor along the frontage of #109 the sidewalk would be built adjacent to existing curb without utility strip.

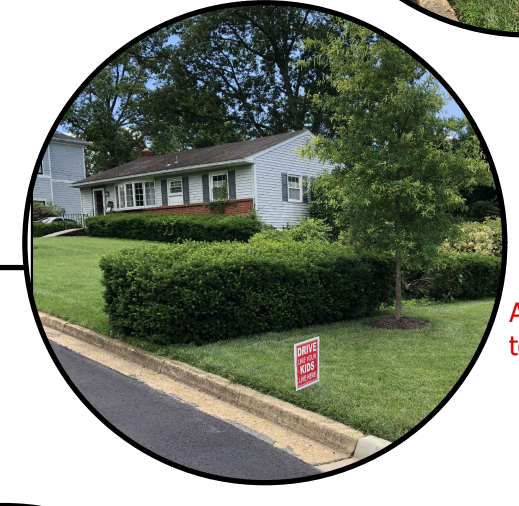
At #107 the shrubs in the TOV R/W will need to be removed to construct the new sidewalk.

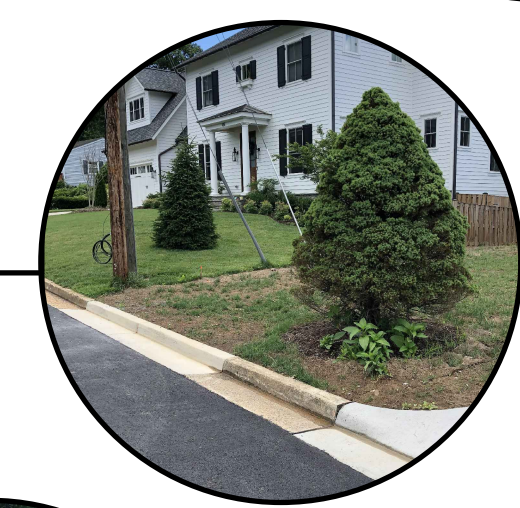
At the location of the utility pole between #103 and #105 the sidewalk would be built adjacent to existing curb without utility strip.

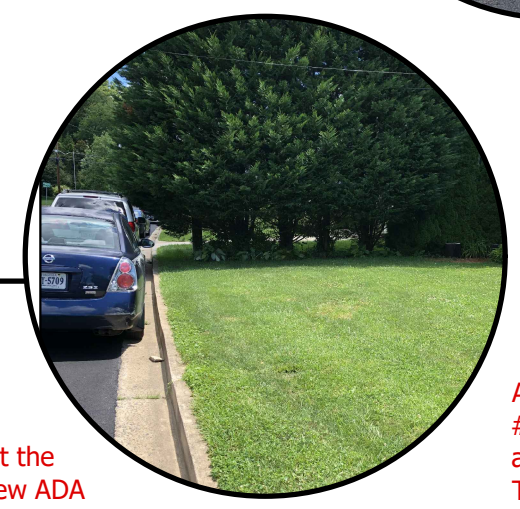
At the location of the utility pole between #102 and #100 the sidewalk would be built adjacent to existing curb without utility strip. The branches of the Leyland Cypress will need to be trimmed or the tree, or the tree can be removed.

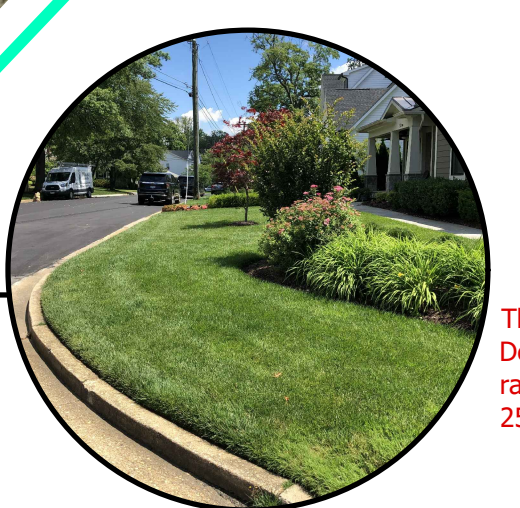
The new sidewalk will end at the Desale intersection with a new ADA ramp and smaller curb return radii of 25' provided.

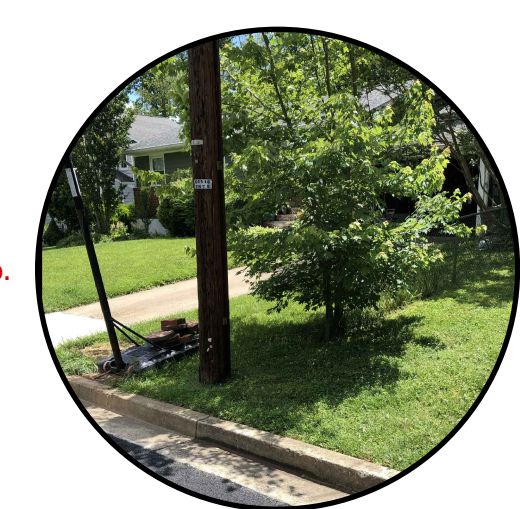
At the location of the utility pole between #110 and #108 the sidewalk would be built adjacent to existing curb without utility strip.

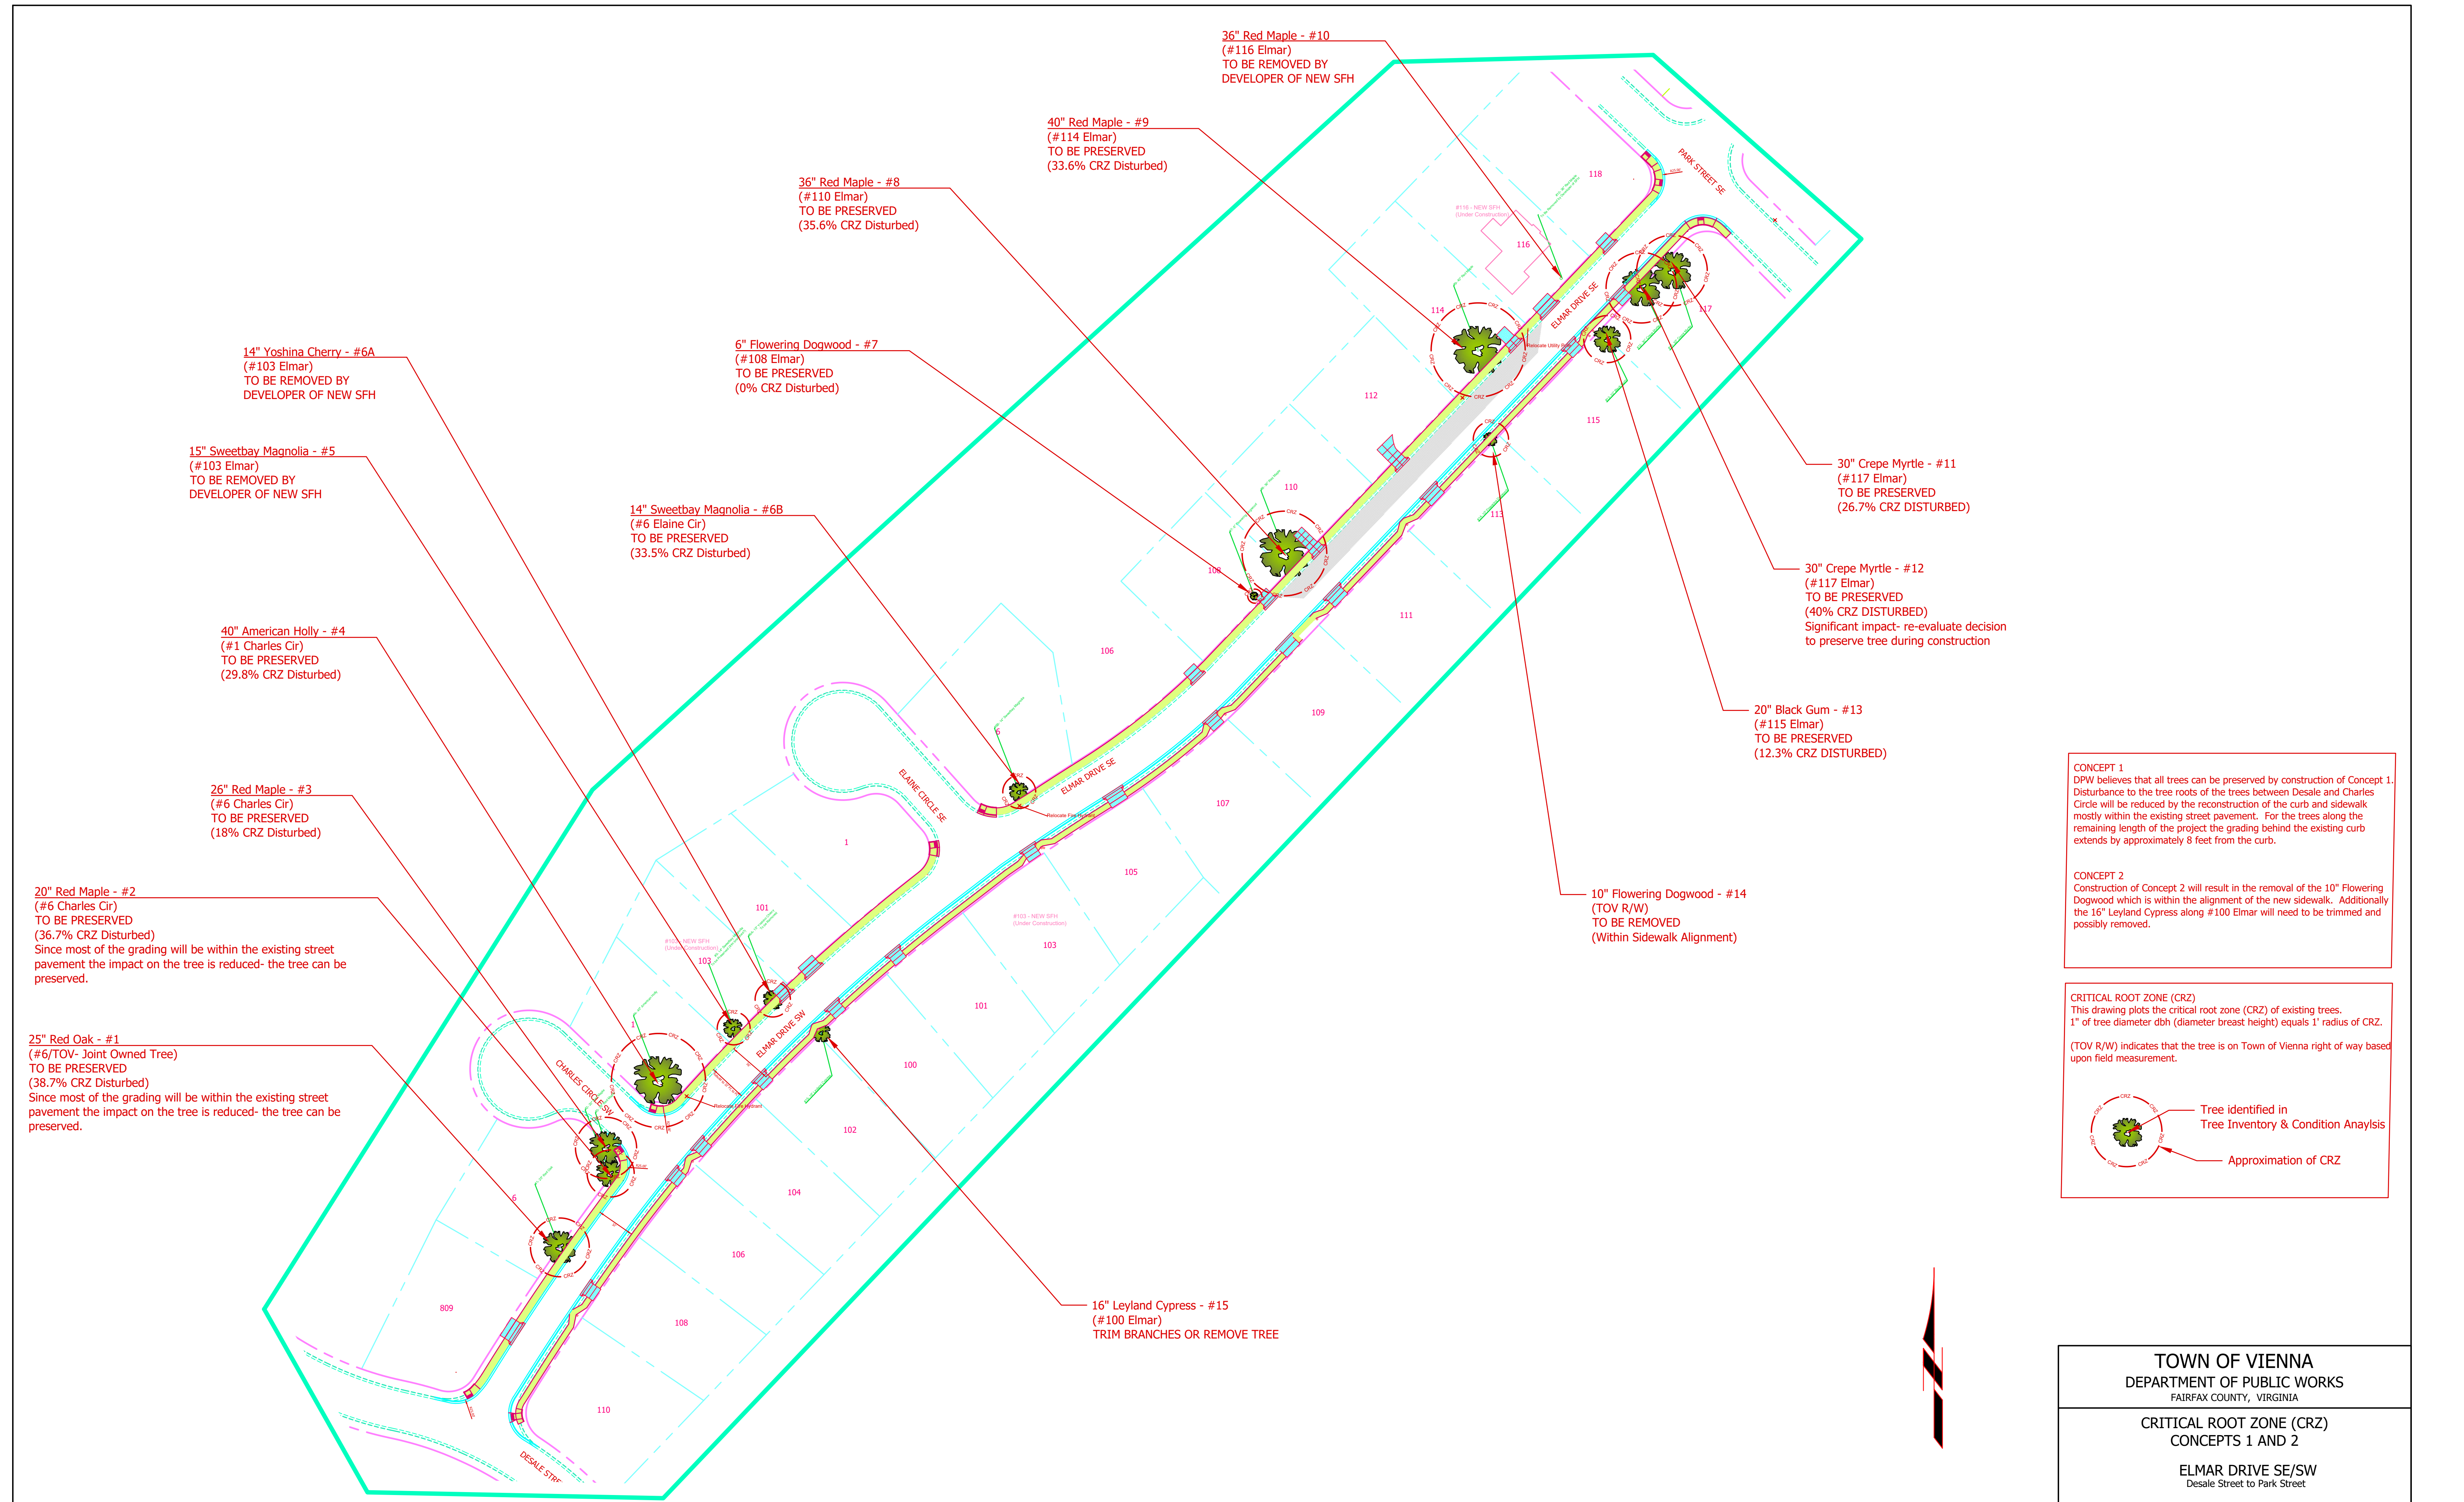
CRITICAL ROOT ZONE (CRZ)
 CONCEPTS 1 AND 2

40" American Holly - #4
 (#1 Charles Cir)
 TO BE PRESERVED
 (29.8% CRZ Disturbed)

26" Red Maple - #3
 (#6 Charles Cir)
 TO BE PRESERVED
 (18% CRZ Disturbed)

20" Red Maple - #2
 (#6 Charles Cir)
 TO BE PRESERVED
 (36.7% CRZ Disturbed)
 Since most of the grading will be within the existing street
 pavement the impact on the tree is reduced- the tree can be
 preserved.

25" Red Oak - #1
 (#6/TOV- Joint Owned Tree)
 TO BE PRESERVED
 (38.7% CRZ Disturbed)
 Since most of the grading will be within the existing street
 pavement the impact on the tree is reduced- the tree can be
 preserved.

36" Red Maple - #8
 (#110 Elmar)
 TO BE PRESERVED
 (35.6% CRZ Disturbed)

14" Sweetbay Magnolia - #6B
 (#6 Elaine Cir)
 TO BE PRESERVED
 (33.5% CRZ Disturbed)

40" Red Maple - #9
 (#114 Elmar)
 TO BE PRESERVED
 (33.6% CRZ Disturbed)

30" Crepe Myrtle - #11
 (#117 Elmar)
 TO BE PRESERVED
 (26.7% CRZ DISTURBED)

30" Crepe Myrtle - #12
 (#117 Elmar)
 TO BE PRESERVED
 (40% CRZ DISTURBED)
 Significant impact- re-evaluate decision
 to preserve tree during construction

10" Flowering Dogwood - #14
 (TOV R/W)
 TO BE REMOVED
 (Within Sidewalk Alignment)

16" Leyland Cypress - #15
 (#100 Elmar)
 TRIM BRANCHES OR REMOVE TREE

CONCEPT 1
 DPW believes that all trees can be preserved by construction of Concept 1. Disturbance to the tree roots of the trees between Desale and Charles Circle will be reduced by the reconstruction of the curb and sidewalk mostly within the existing street pavement. For the trees along the remaining length of the project the grading behind the existing curb extends by approximately 8 feet from the curb.

CONCEPT 2
 Construction of Concept 2 will result in the removal of the 10" Flowering Dogwood which is within the alignment of the new sidewalk. Additionally the 16" Leyland Cypress along #100 Elmar will need to be trimmed and possibly removed.
