CONCEPT 1
DESALE STREET SW
CONCEPT STUDY
TOWN OF VIENNA
FAIRFAX COUNTY, VIRGINIA
DATE: MAY, 2022
SCALE: 1"=30'
C.I. N/A

Tree Inventory and Condition Analysis
Completed: 12/22/2021
Kevin J. Tankersley, ISA Certified Arborist #MA-5871A

TREE INVENTORY & CONDITION ANALYSIS

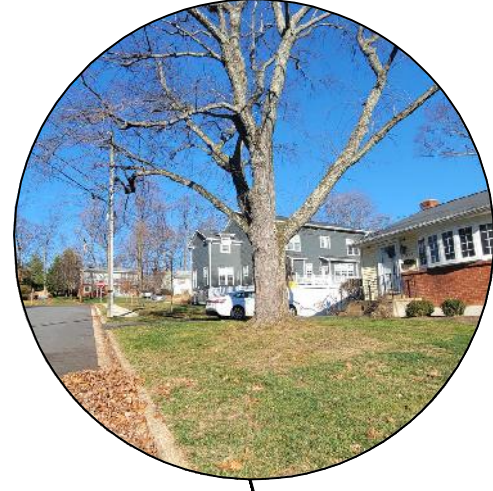
38" RED MAPLE (TREE#45) IN GOOD CONDITION. TREE IS ON SLOPE. VERY LIKELY THAT THE STRUCTURAL ROOT ZONE OF THE TREE WILL BE AFFECTED. TREE TO BE REMOVED.

44	<i>Acer palmatum var. dissectum</i>	Weeping Japanese Maple	7"	8.0'	7'	4'	Good	78.13		Very close to path of walk; may require pruning which would affect shape.
45	<i>Acer rubrum</i>	Red Maple	38"	28'	38'	19'	Good	71.88		Tree is on slope. Very likely that the structural root zone of the tree will be affected, even if the walk is positioned against the curb.

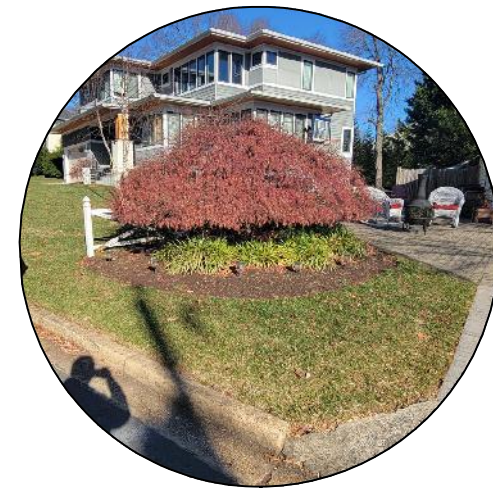
7" WEeping JAPANESE MAPLE (TREE#44) IN GOOD CONDITION. VERY CLOSE TO PATH OF SIDEWALK. PRUNING MAY BE REQUIRED.

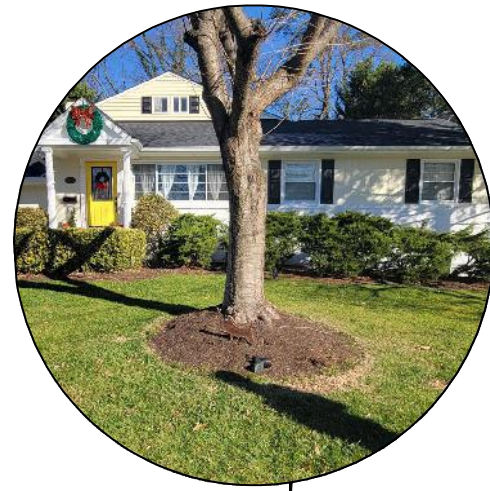
20" YOSHINO CHERRY (TREE#43) IN GOOD CONDITION. ON SLOPE, GRADING MAY IMPACT CRITICAL ROOT ZONE.

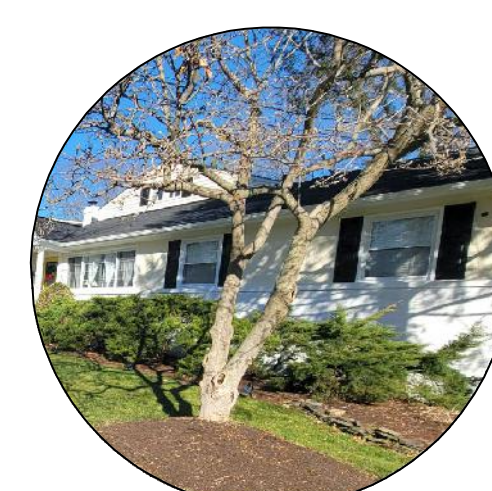
12" SAUCER MAGNOLIA (TREE#42) IN GOOD CONDITION. CO-DOMINANT

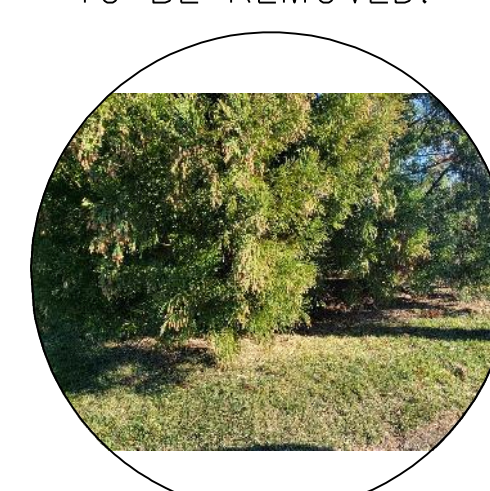
10" JAPANESE CRYPTOMERIA (TREE#40) & 12" JAPANESE CRYPTOMERIA (TREE#41) BOTH IN EXCELLENT CONDITION. ADJACENT TO THE SIDEWALK AREA. BRANCHES WOULD HAVE TO BE PRUNED AWAY OR TREE TO BE REMOVED.

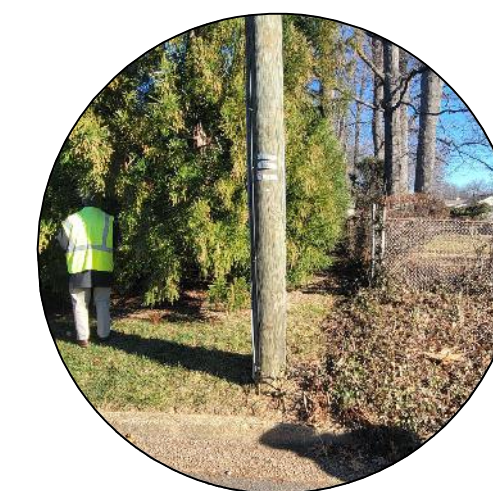
UTILITY POLE WITH GUY WIRE. SIDEWALK TO BE PROPOSED AT THE BACK OF THE POLE. ADJUST SIDEWALK WIDTH TO MINIMUM 4'.

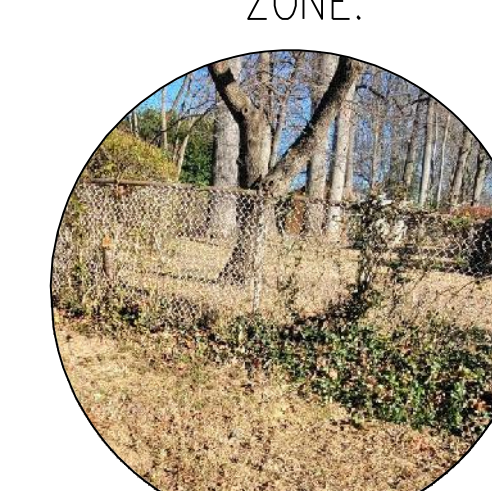
14" FLOWERING DOGWOOD (TREE#39) IN FAIR CONDITION. CO-DOMINANT WITH DECAY. SIGNIFICANTLY HIGHER THAN CURB, GRADING FOR WALK MAY IMPACT CRITICAL ROOT ZONE.

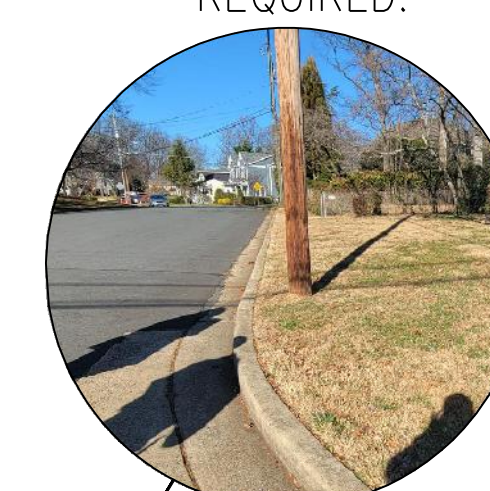
UTILITY POLE WITH GUY WIRE. SIDEWALK TO BE PROPOSED AT THE BACK OF THE POLE. ADJUST SIDEWALK WIDTH TO MINIMUM 4'. EASEMENT OR RIGHT OF ENTRY MAY BE REQUIRED.

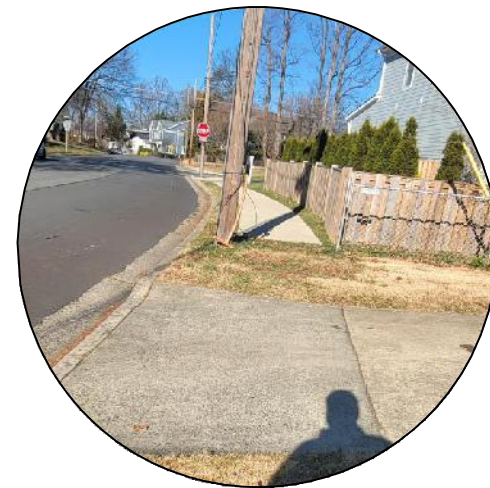
UTILITY POLE WITH GUY WIRE. SIDEWALK TO BE PROPOSED AT THE BACK OF THE POLE. ADJUST SIDEWALK WIDTH TO MINIMUM 4'. TIE WITH EX. SIDEWALK

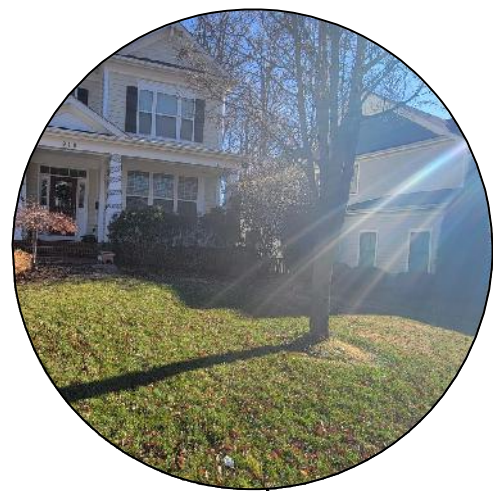
8" ARISTOCRAT PEAR (TREE#37) IN GOOD CONDITION. ON SLIGHT UPHILL SLOPE; GRADING MAY IMPACT TREE.

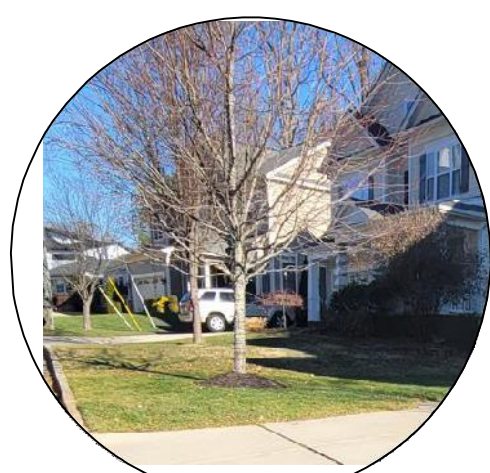
6" RED MAPLE (TREE#36) IN EXCELLENT CONDITION. CRITICAL ROOT ZONE MAY BE IMPACTED.

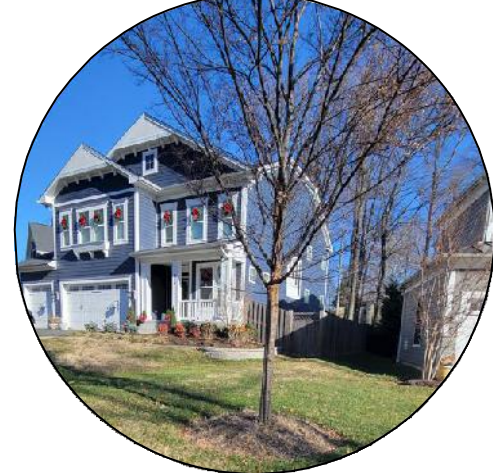
5" CHINESE ELM (TREE#34) IN EXCELLENT CONDITION. YOUNG TREE CLOSE TO PATH OF WALK; MAY BE AFFECTED.

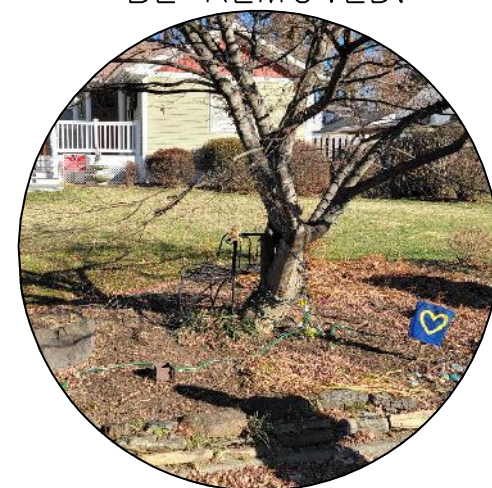
14" JAPANESE MAPLE (TREE#33) IN GOOD CONDITION. LOW BRANCHES OVERHANG STREET; TREE IS IN PATH OF WALK, TREE TO BE REMOVED.

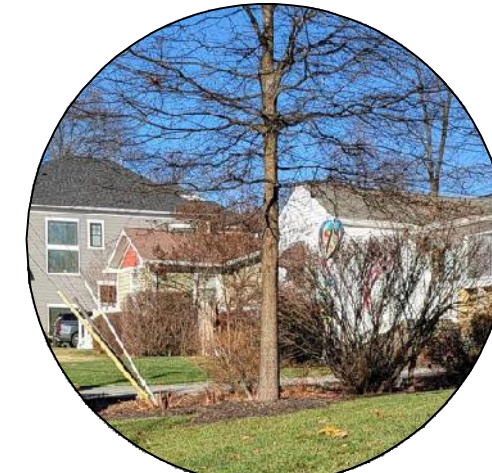
8" WILLOW OAK (TREE#30) IN EXCELLENT CONDITION. YOUNG TREE.

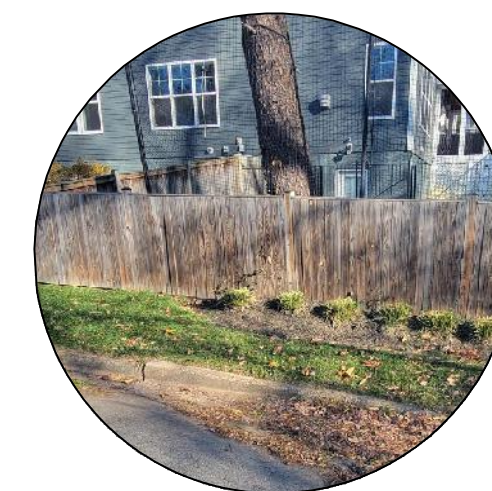
23" VIRGINIA PINE (TREE#27), DEAD. TREE TO BE REMOVED.

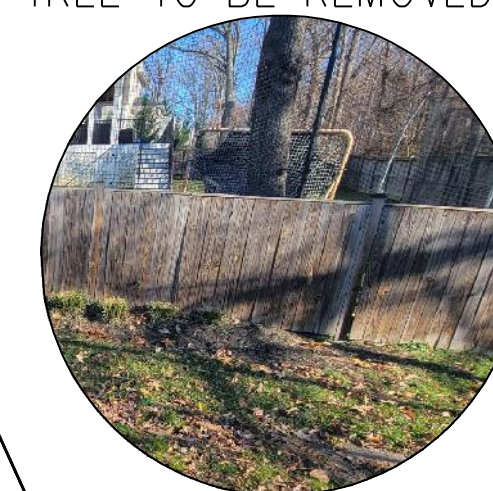
13" TULIP POPLAR (TREE#26) IN FAIR CONDITION. POOR & SUFFERING FROM CONSTRUCTION DAMAGE. TREE TO BE REMOVED.

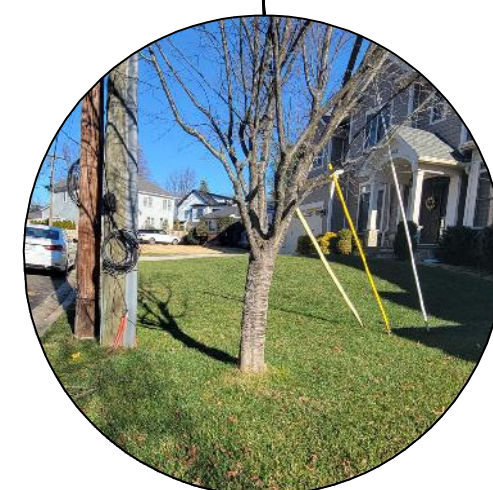
6" YOSHINO CHERRY (TREE#38) IN GOOD CONDITION. SLIGHT LEAN. TREE IS CLOSE TO UTILITY POLE AND IN PATH OF WALK. TREE TO BE REMOVED. PROPOSE SIDEWALK AT THE BACK OF POLE.

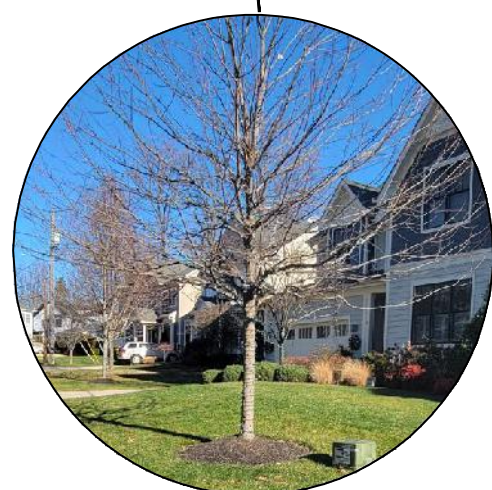
6" RED MAPLE (TREE#35) IN EXCELLENT CONDITION. TREE IS CLOSE TO ROW. CRITICAL ROOT ZONE MAY BE AFFECTED.

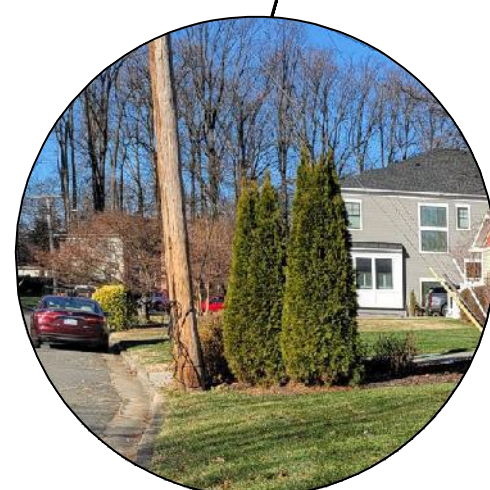
2-5" AMERICAN ARBORVITAE (TREE#31 & 32) IN EXCELLENT CONDITION. IN PATH OF WALK. TREES TO BE REMOVED. SIDEWALK TO BE PROPOSED AT THE BACK OF POLE WITH MINIMUM 4' WIDTH.

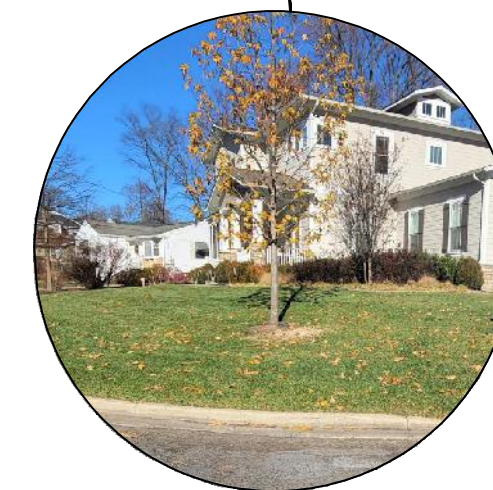
4" SWEETGUM (TREE#29) IN EXCELLENT CONDITION. YOUNG TREE. ON SLIGHT SLOPE, GRADING MAY IMPACT CRITICAL ROOT ZONE.

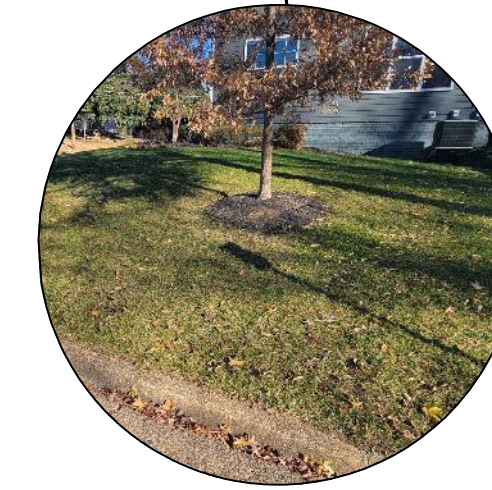
6" CHESTNUT OAK (TREE#28) IN EXCELLENT CONDITION. YOUNG TREE. UPHILL SLOPE. GRADING MAY IMPACT CRITICAL ROOT ZONE.

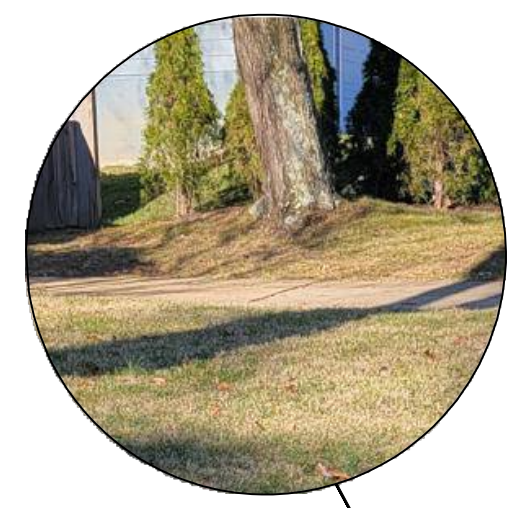
24" RED MAPLE (TREE#1) IN GOOD CONDITION. SLIGHT LEAN; CO-DOMINANT

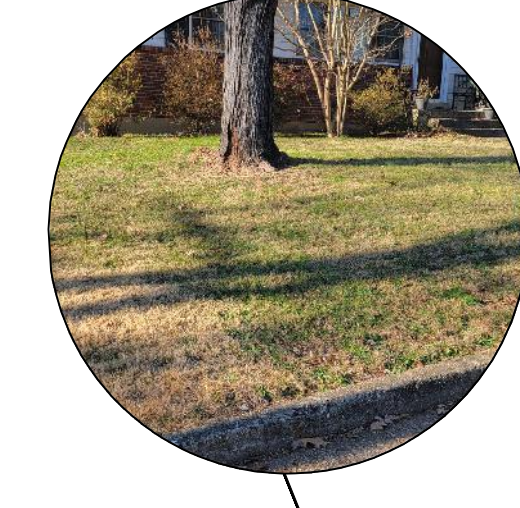
24" RED MAPLE (TREE#2) IN POOR CONDITION. NEARLY DEAD, SIGNIFICANT DECAY; ONE-SIDED CANOPY

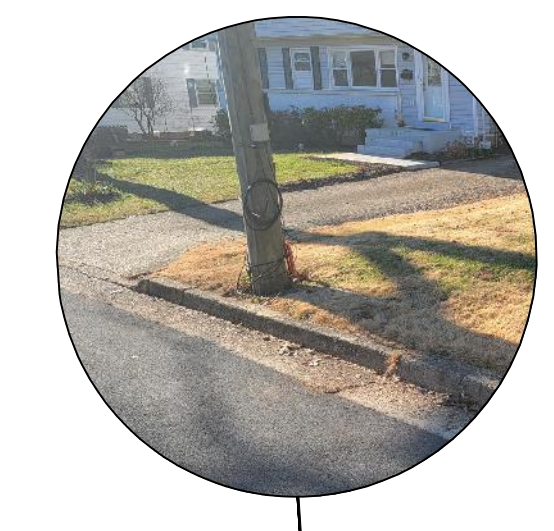
UTILITY POLE WITH GUY WIRE. INSTALL SIDEWALK AT THE BACK OF THE POLE AND REDUCE WIDTH TO MINIMUM 4'.

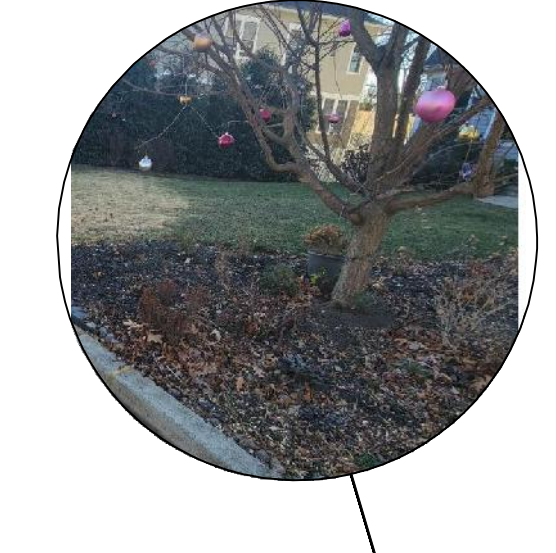
8" YOSHINO CHERRY (TREE#5) IN GOOD CONDITION. TREE IS IN ROW. TREE TO BE REMOVED.

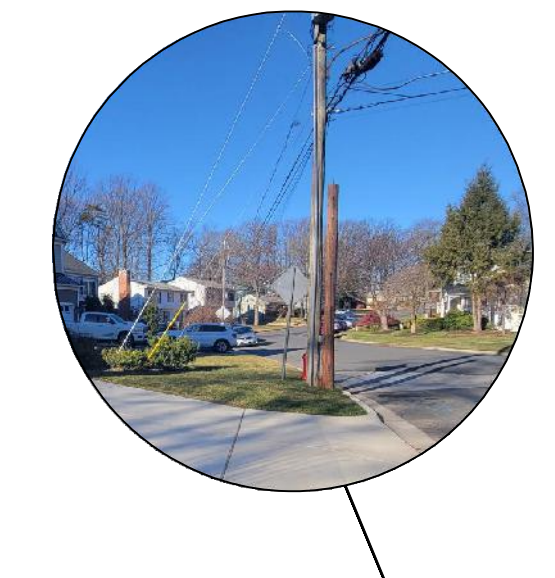
UTILITY POLE WITH GUY WIRE. SIDEWALK TO BE PROPOSED AT THE BACK OF THE POLE. ADJUST SIDEWALK WIDTH TO MINIMUM 4'.

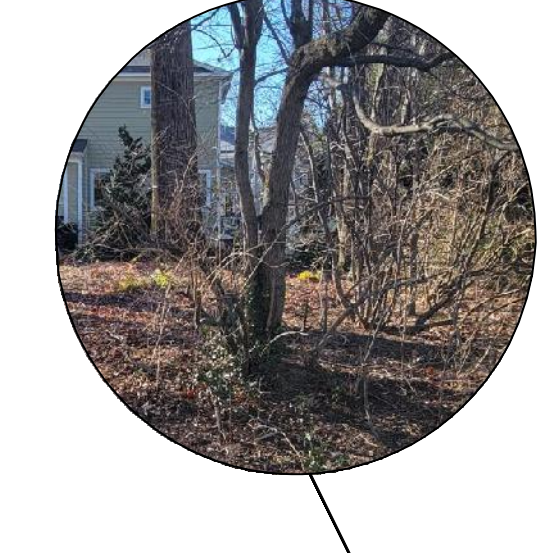
26" RED MAPLE IN (TREE#7) GOOD CONDITION. CO-DOMINANT. GRADING MAY IMPACT CRITICAL ROOT ZONE.

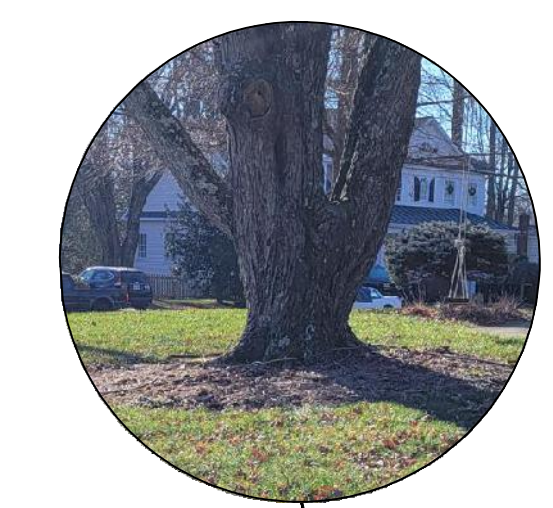
32" RED MAPLE (TREE#9) IN FAIR CONDITION. TRUNK DECAY. MULTI-TRUNK WITH POOR STRUCTURE.

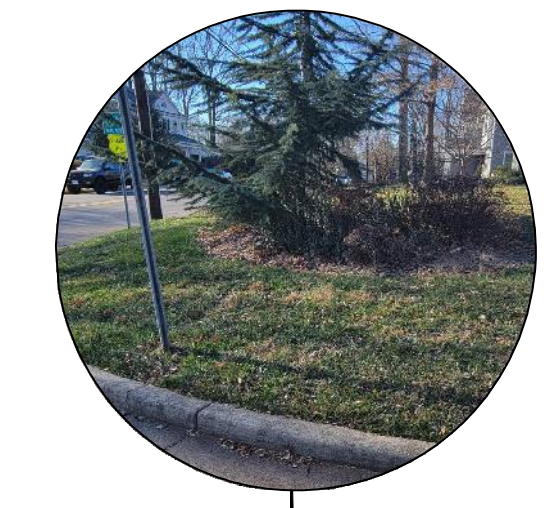
6" DEODAR CEDAR (TREE#10) IN GOOD CONDITION. YOUNG TREE. ON SLOPE; GRADING MAY IMPACT CRITICAL ROOT ZONE.

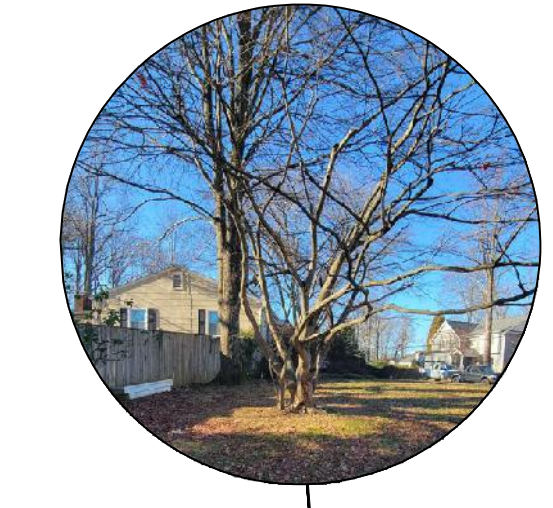
30" JAPANESE MAPLE (TREE#11) IN FAIR CONDITION. SIGNIFICANT TRUNK DECAY, LOW BRANCHES & DIEBACK.

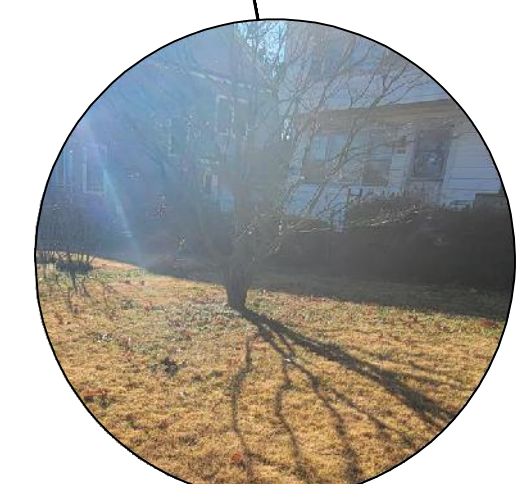
24" RED MAPLE (TREE#3) IN GOOD CONDITION. STREET SIDE HEAVILY PRUNED FOR POWER LINES. TREE TO BE REMOVED

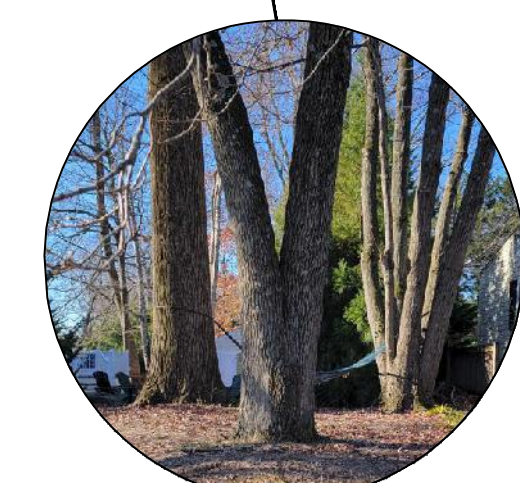
8" RED MAPLE (TREE#6) IN GOOD CONDITION. CO-DOMINANT; SEVERE V CROTCH

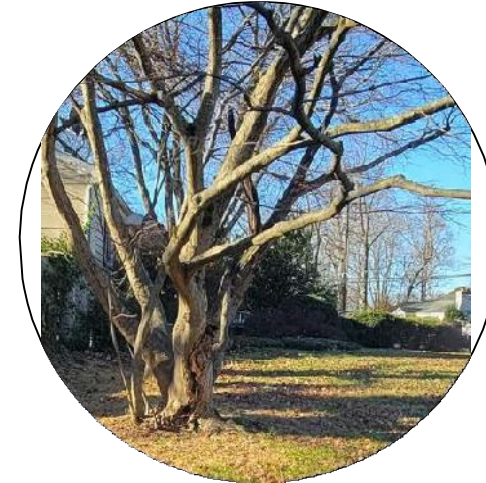
20" RED MAPLE (TREE#12) IN GOOD CONDITION. SIDEWALK MAY IMPACT THE STRUCTURAL ROOT ZONE. TREE TO BE REMOVED.

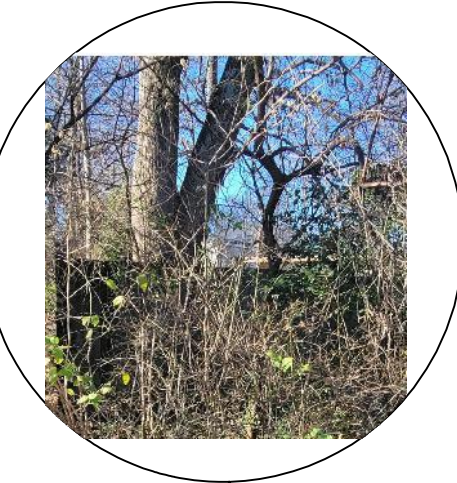
46" TULIP POPLAR (TREE#13) IN GOOD CONDITION. VERY LARGE CO-DOMINANT WITH EXTENSIVE CRITICAL ROOT ZONE.

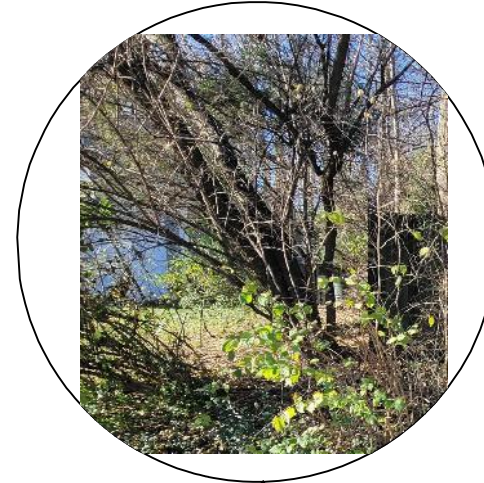
16" MULTI-TRUNK RED MAPLE (TREE#14) IN FAIR CONDITION. LEANING OVER. VERY CLOSE TO WALKWAY LOCATION, IMPACT TO CRITICAL ROOT ZONE.

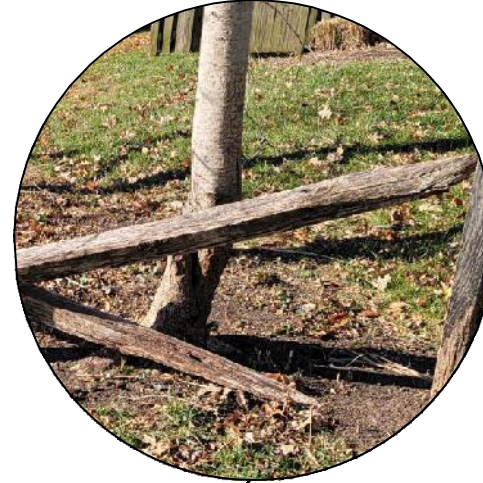
6" WEeping CHERRY (TREE#15) IN GOOD CONDITION. TRUNK DECAY, TREE IN PATH OF WALK. TREE TO BE REMOVED.

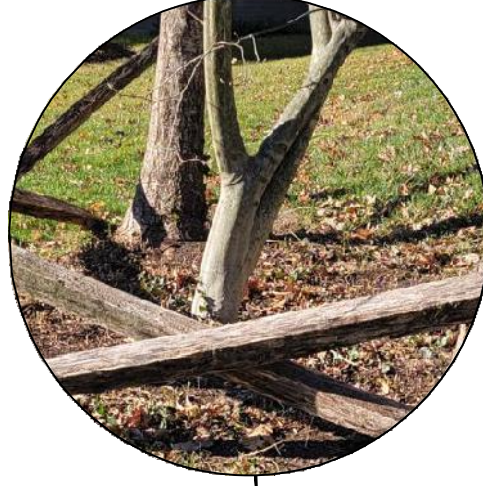
6" SAUCER MAGNOLIA (TREE#16) IN GOOD CONDITION. TREE AT PATH OF THE SIDE WALK. SIGNIFICANT IMPACT TO TREE. TREE TO BE REMOVED.

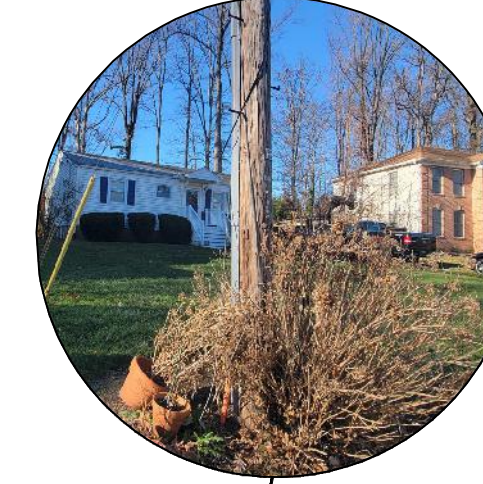
UTILITY POLE WITH GUY WIRE. SIDEWALK TO BE PROPOSED AT THE BACK OF THE POLE. ADJUST SIDEWALK WIDTH TO MINIMUM 4'.

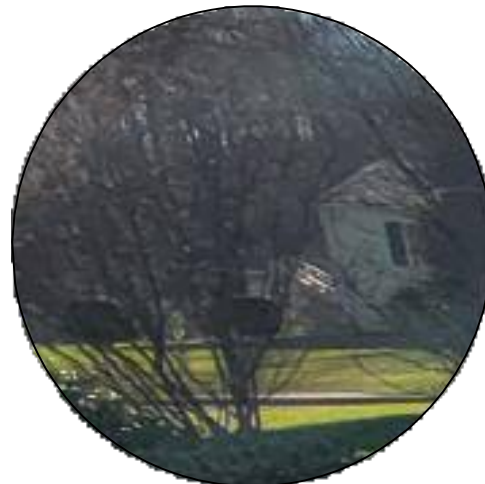
2" FLOWERING DOGWOOD (TREE#23) IN GOOD CONDITION. TREE IN THE PATH OF SIDEWALK. TREE TO BE REMOVED.

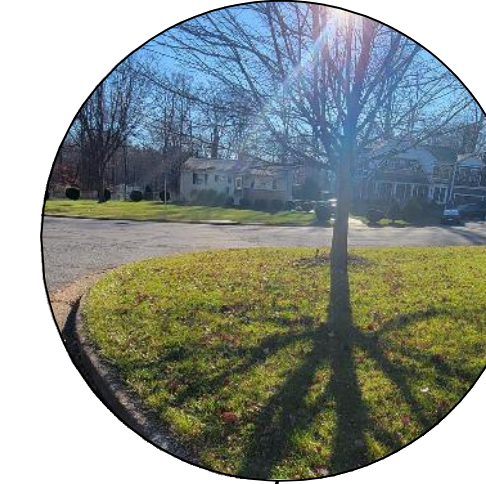
11" RED MAPLE (TREE#24) IN EXCELLENT CONDITION. TREE ON SLOPE, GRADING WOULD IMPACT CRITICAL ROOT ZONE.

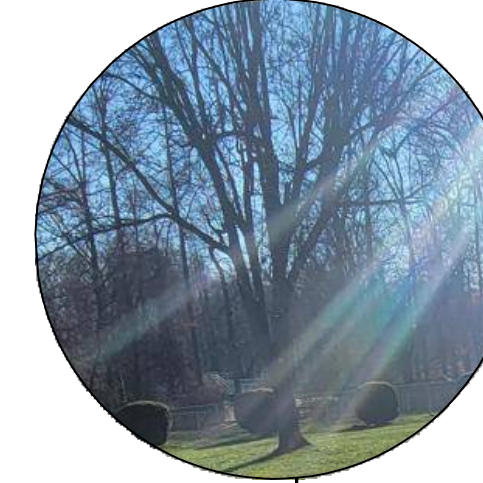
14" RED MAPLE (TREE#25) IN GOOD CONDITION.

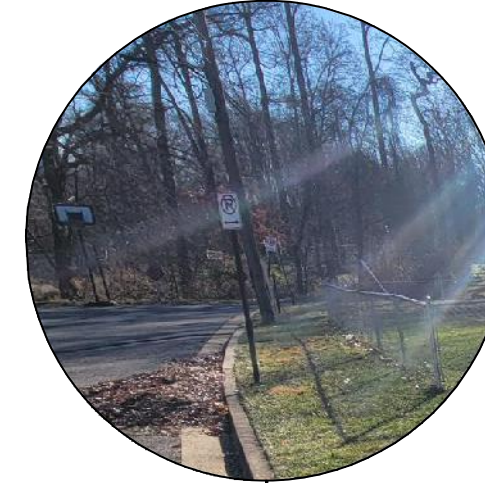
UTILITY POLE WITH GUY WIRE. SIDEWALK TO BE PROPOSED AT THE BACK OF THE POLE. ADJUST SIDEWALK WIDTH TO MINIMUM 4'.

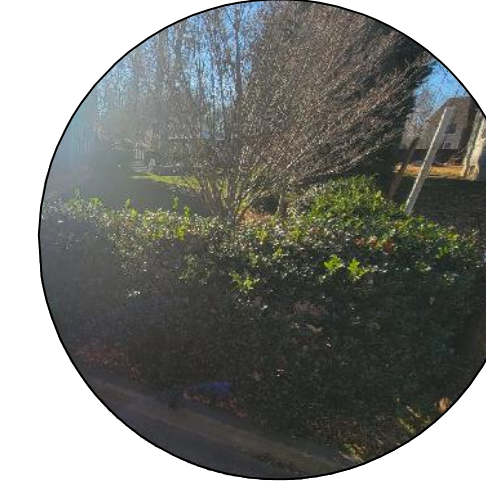
4" KOUSA DOGWOOD (TREE#19) IN EXCELLENT CONDITION. TREE IN PATH OF SIDEWALK. TREE TO BE REMOVED.

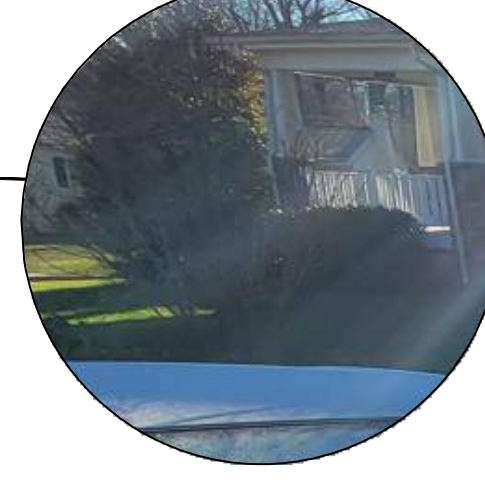
3" KOUSA DOGWOOD (TREE#21) IN GOOD CONDITION. TREE IN PATH OF SIDEWALK. TREE TO BE REMOVED.
