S OF CONCEPT 1 AND CONCEORRIN STREET SESIDEWALK STUDY

Orrin St. SE Vienna, VA

Tree Inventory and Condition Analysis Completed: 01/13/2022 Kevin J. Tankersley, ISA Certified Arborist #MA-5871A

TREE INVENTORY AND CONDITION ANALYSIS
ORRIN STREET SE
SIDEWALK STUDY
TOWN OF VIENNA
FAIRFAX COUNTY, VIRGINIA

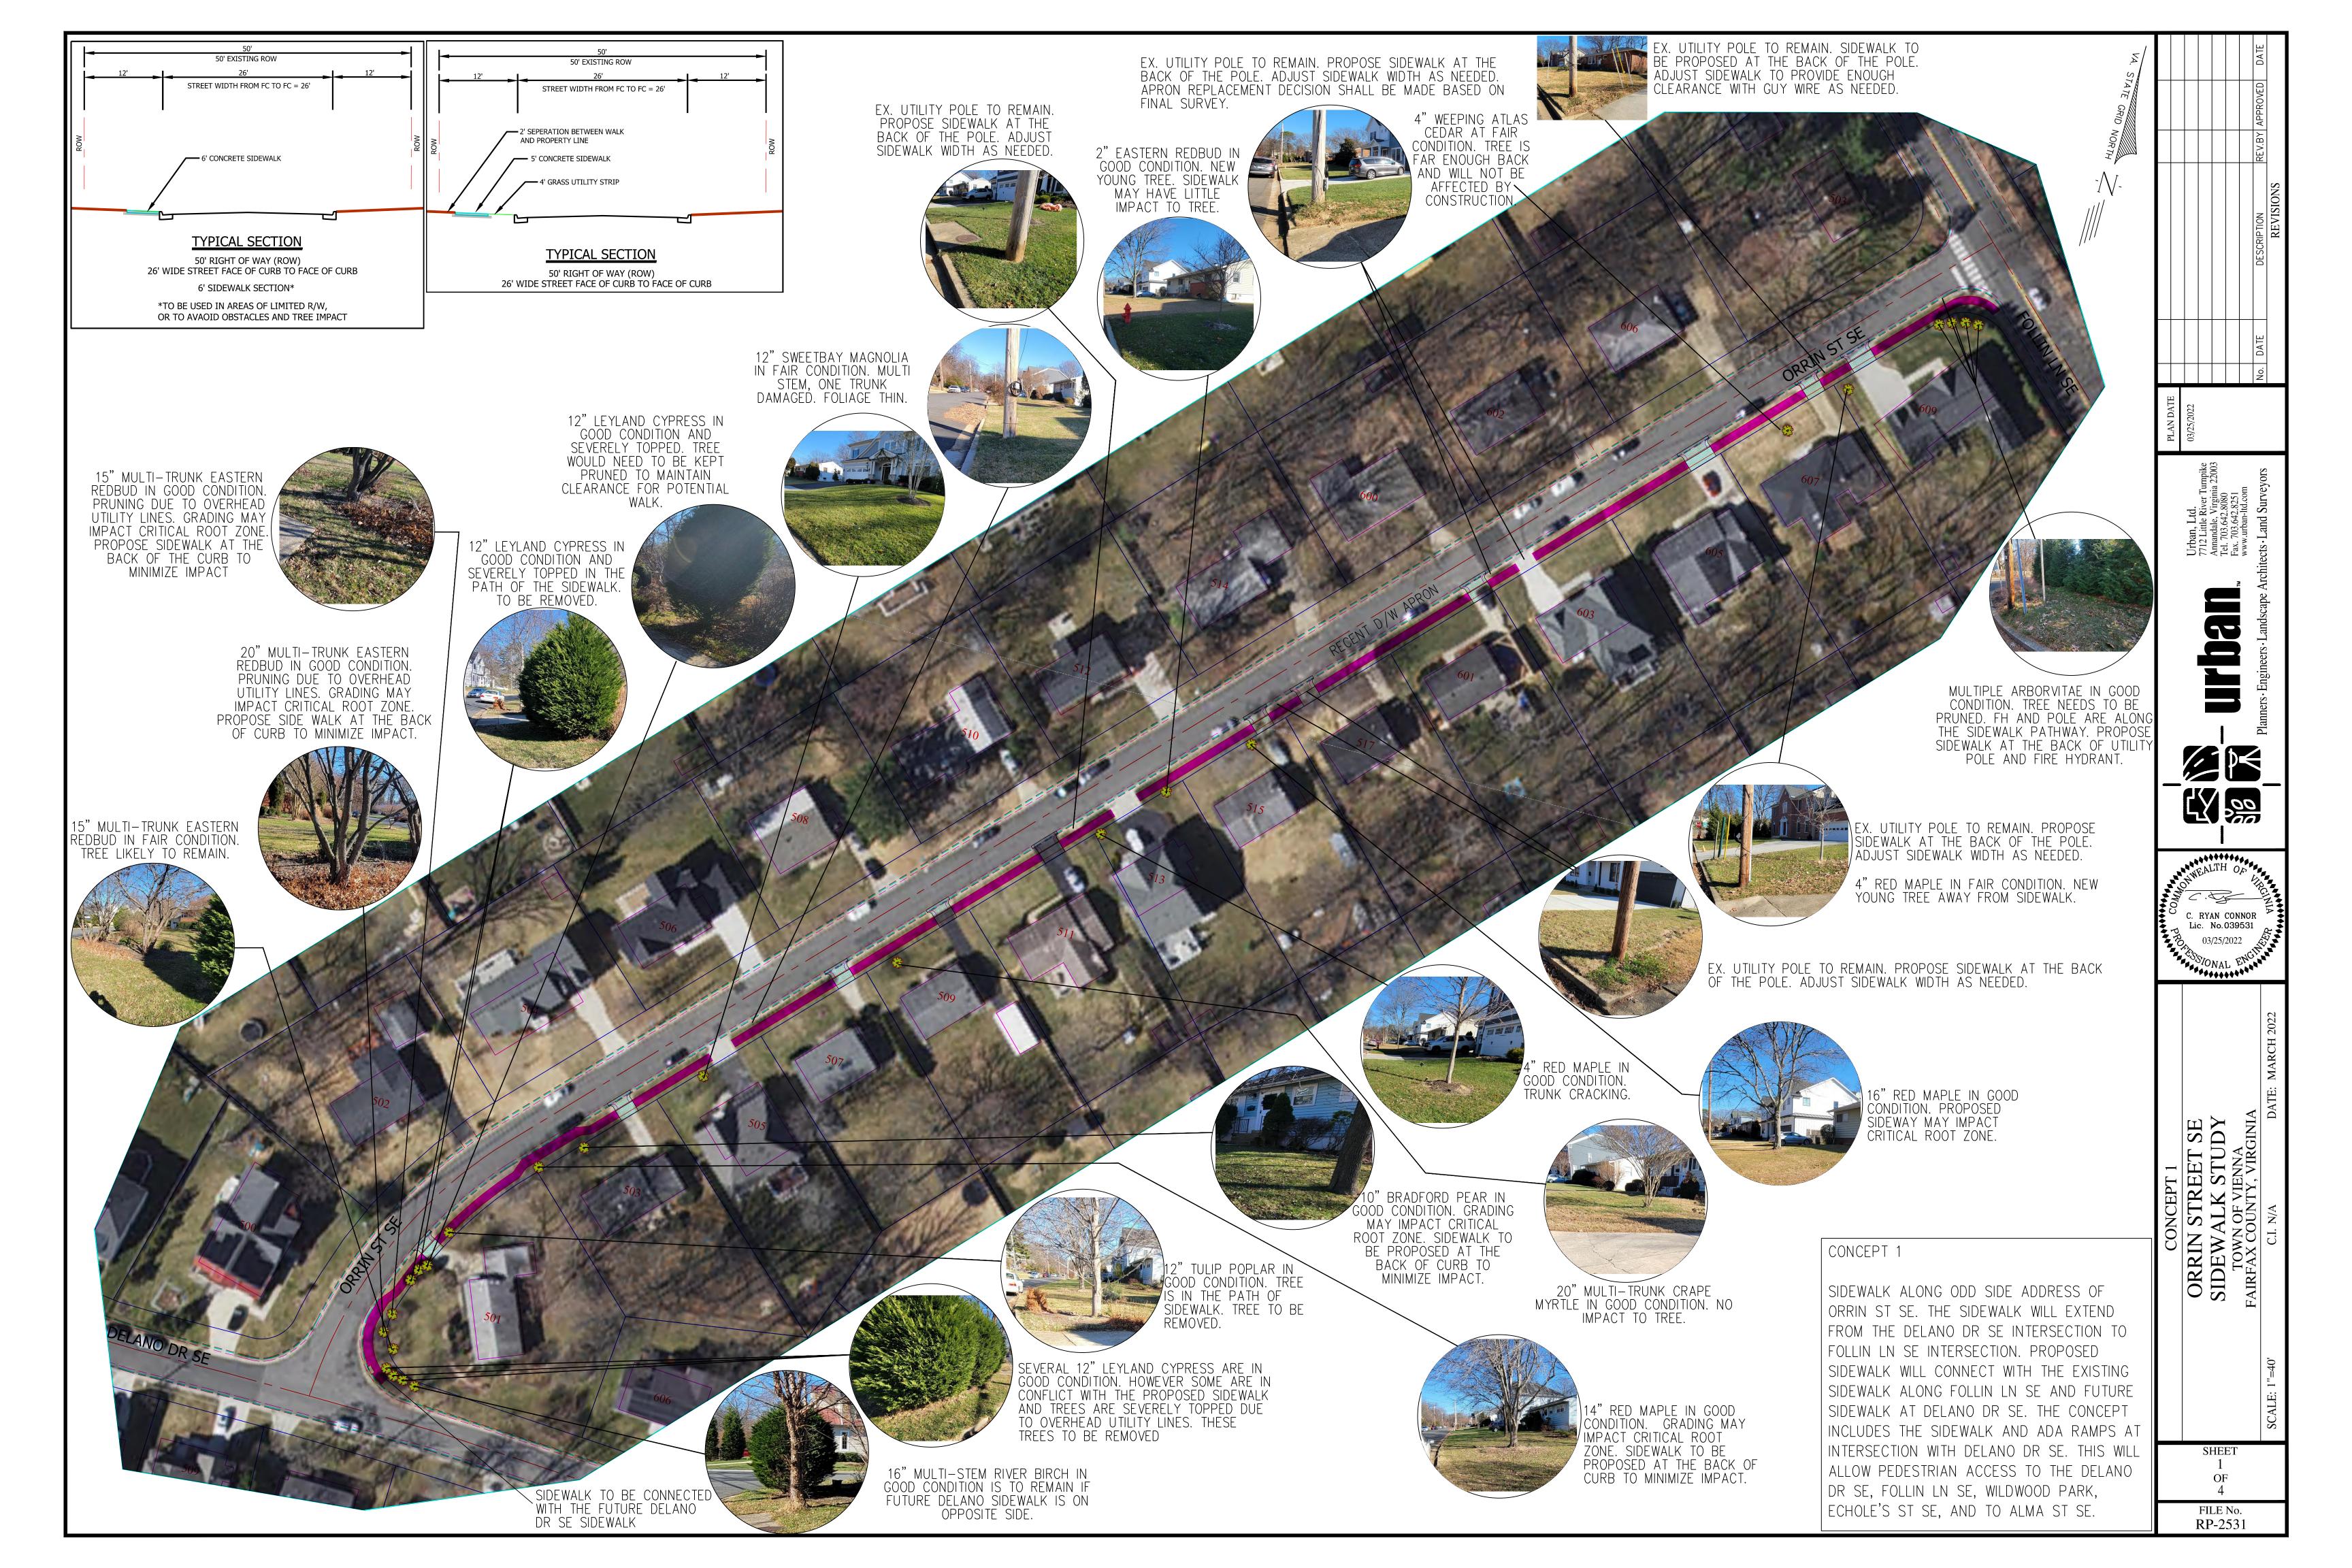
ANALYSIS OF CONCEPT 1- ORRIN ST SE

TREE IMPACT	RELATIVELY FEW TREES ARE AFFECTED WITH THE ROUTING OF THE SIDEWALK IN CONCEPT 1 ALONG THE SOUTH SIDE OF THE STREET. APPROXIMATELY FIVE TREES WILL NEED TO BE REMOVED, AND AN ADDITIONAL THREE TREES MAY HAVE IMPACTS TO THEIR CRITICAL ROOT ZONES DEPENDING ON THE EXTENT OF GRADING FOR THE WALK ADJACENT TO THEM OF THE TREES TO BE REMOVED, APPROXIMATELY THREE ARE LOCATED AT 501 ORRIN STREET. THESE TREES ARE LOCATED CLOSE TO THE STREET AND UNDERNEATH/ADJACENT TO OVERHEAD POWER LINES.AS A RESULT THEY HAVE BEEN SEVERELY PRUNED BY THE UTILITY COMPANY WHICH NEGATIVELY AFFECTS THEIR OVERALL CONDITION, AND WHILE SMALL, MAKES THEM NOT SUITABLE CANDIDATES FOR TRANSPLANTING.	FOR THE ROUTING OF THE WALK ON THE NORTH SIDE OF ORRIN ST., NINE TREES WOULD NEED TO BE REMOVED, AND AN ADDITIONAL FOUR EITHER REMOVED OR POSSIBLY TRANSPLANTED. AN ADDITIONAL FOUR LARGER TREES MAY SUFFER IMPACTS TO THEIR CRITICAL ROOT ZONES DEPENDING ON THE EXTENT OF GRADING FOR THE CONSTRUCTION OF THE SIDEWALK.

CONSTRUCTABILITY ISSUE	THERE DO NOT APPEAR TO BE SIGNIFICANT CONSTRUCTABILITY ISSUES WITH THIS CONCEPT. THERE ARE MORE UTILITY POLES ALONG THIS CONCEPT. HOWEVER IN THE AREA OF THE UTILITY POLES THERE IS SUFFICIENT CLEARANCE FOR THE SIDEWALK BETWEEN THE BACK OF POLE AND GUY WIRES.	THERE DO NOT APPEAR TO BE SIGNIFICANT CONSTRUCTABILITY ISSUES WITH THIS CONCEPT. IN THE AREA OF THE UTILITY POLES THERE IS SUFFICIENT CLEARANCE FOR THE SIDWALK BETWEEN THE POLE AND GUY WIRES.
COST	THE COST OF THIS CONCEPT IS COMPARABLE TO OTHER ROBINSON SIDEWALK PROJECTS. BOTH THE CONCEPTS WILL HAVE SIMILAR COSTS COMPARED TO EACH OTHER.	THE COST OF THIS CONCEPT IS COMPARABLE TO OTHER ROBINSON SIDEWALK PROJECTS. BOTH THE CONCEPTS WILL HAVE SIMILAR COSTS COMPARED TO EACH OTHER.
CONNECTIVITY	BOTH THE CONCEPTS HAVE SIMILAR CONNECTIVITY TO NEIGHBORRING STREET AND WILDWOOD PARK VIA DELANO DR SE. THIS CONCEPT PROVIDES ACCESS TO MORE HOMEOWNERS COMPARED TO CONCEPT 2.	BOTH THE CONCEPTS HAVE SIMILAR CONNECTIVITY TO NEIGHBORRING STREET AND WILDWOOD PARK VIA DELANO DR SE.

RECOMMENDATION	CONCEPT 1 HAS MINIMUM GRADING IMPACTS AND LESSER NUMBER OF TREES IMPACTS. CONCEPT 1 IS RECOMMENDED.	CONCEPT 1 PROVIDES DIRECT PEDESTRIAN ACCESS TO MORE HOMEOWNERS. HENCE,
