## Bear Branch Tributary Phase II – Southside Park Stream Restoration Grant Proposal

*Stormwater Local Assistance Fund Fiscal Year 2020*

Town of Vienna, Virginia - Grant Proposal for a Stream Restoration Project to the  
2020 Stormwater Local Assistance Fund

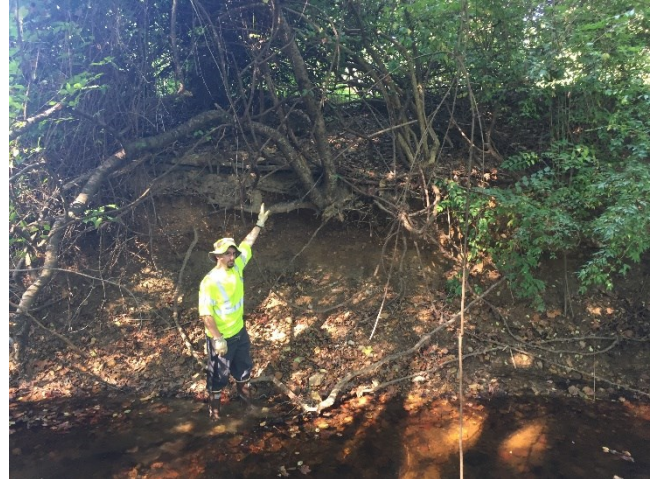
Figure 2. BEHI #8 showing 13' of eroded bank

The current condition of the stream sections have been evaluated onsite and photographed as shown in Figure 2, additional photographs are included in Appendix E. As shown on the Bear Branch Tributary Stream Erosion Evaluation Map included in Appendix C, there are multiple portions of the stream rated extreme for both bank hazard erosion index (BEHI) and near-bank stress risk (NBS). In addition to the site visits and photographs taken, the *Accotink Creek Watershed Management Plan* was reviewed for insight into the phosphorus loads arising from the drainage areas. Figure 2 shows the degree of incision and erosion along the banks. While walking the stream, several areas of 3 feet to 13 feet high, eroded banks are clearly visible. Details for each field-investigated bank can be found in Appendix C. In many of these areas, existing trees have been undermined and overturned. The condition of the stream appears to be a Type III, as described by Figure 3 and indicated in Figure 4 from the *Accotink Creek Watershed Management Plan, Appendix A, Stream Condition Map*.

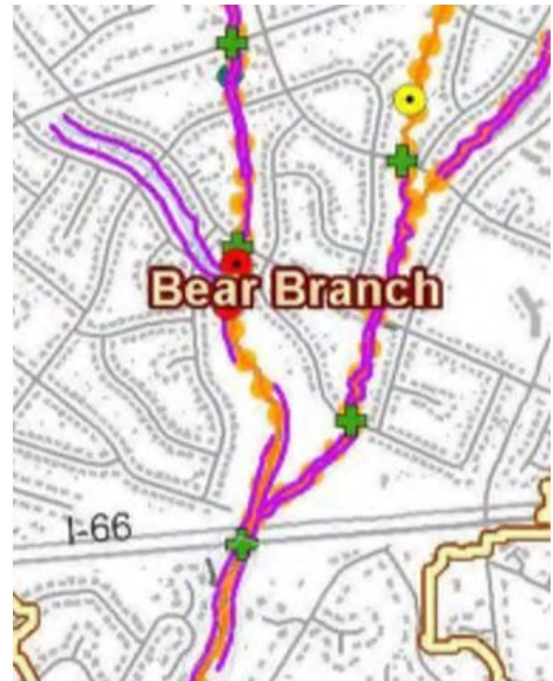
Map 2-7  
**Stream Condition Map**

Figure 4. Accotink Creek Channel Evolution Model Map

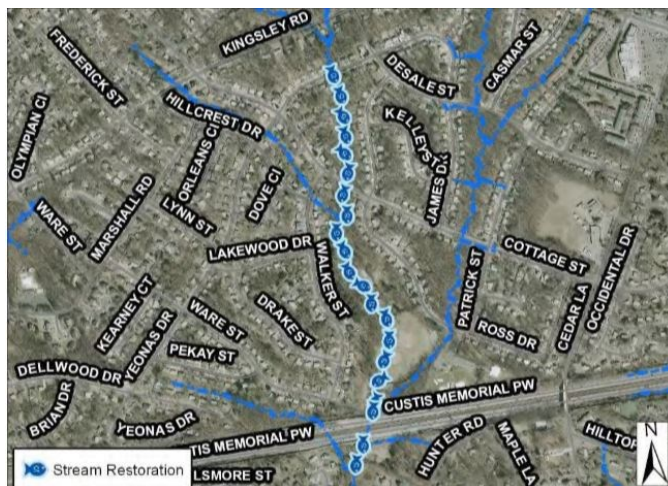
Figure 5. Conceptual Plan showing the limits of Fairfax County’s recommendation

The *Accotink Creek Watershed Management Plan* also outlines this stretch of Bear Branch Tributary as a potential project to help restore and protect the watershed. A project description, benefits, and considerations per the watershed’s plan can be found in this SLAF application’s Section J, Attachment - Section F. A conceptual plan showing the limits of the County’s recommendation can be seen in Figure 5.

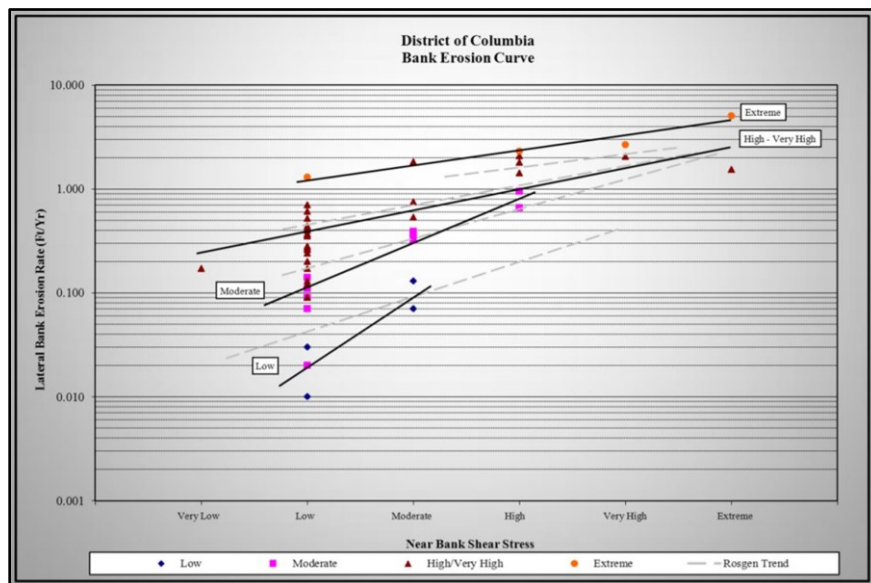
Figure E1 - Bank Erosion Rate Curve Developed by the USFWS

BEHI and NBS rating pairs were used to determine the annual lateral bank erosion rate for each section of streambank using the District of Columbia Bank Erosion Curves (USFWS 2005), see Figure E1. The District of Columbia Curves are based on analysis of Hickey Run, a tributary stream of the Anacostia River in Washington, D.C. Hickey Run is in a highly urbanized area and its watershed consists of a large amount of impervious surfaces and piped tributaries similar to the Bear Branch watershed.
