**MELODY LANE SW**  
**SIDEWALK STUDY**  
TOWN OF VIENNA  
FAIRFAX COUNTY, VIRGINIA

SHEET  
1  
OF  
4

FILE No.  
RP-2530

TREE INVENTORY AND CONDITION ANALYSIS  
MELODY LANE SW  
SIDEWALK STUDY  
TOWN OF VIENNA  
FAIRFAX COUNTY, VIRGINIA  
C.I. N/A

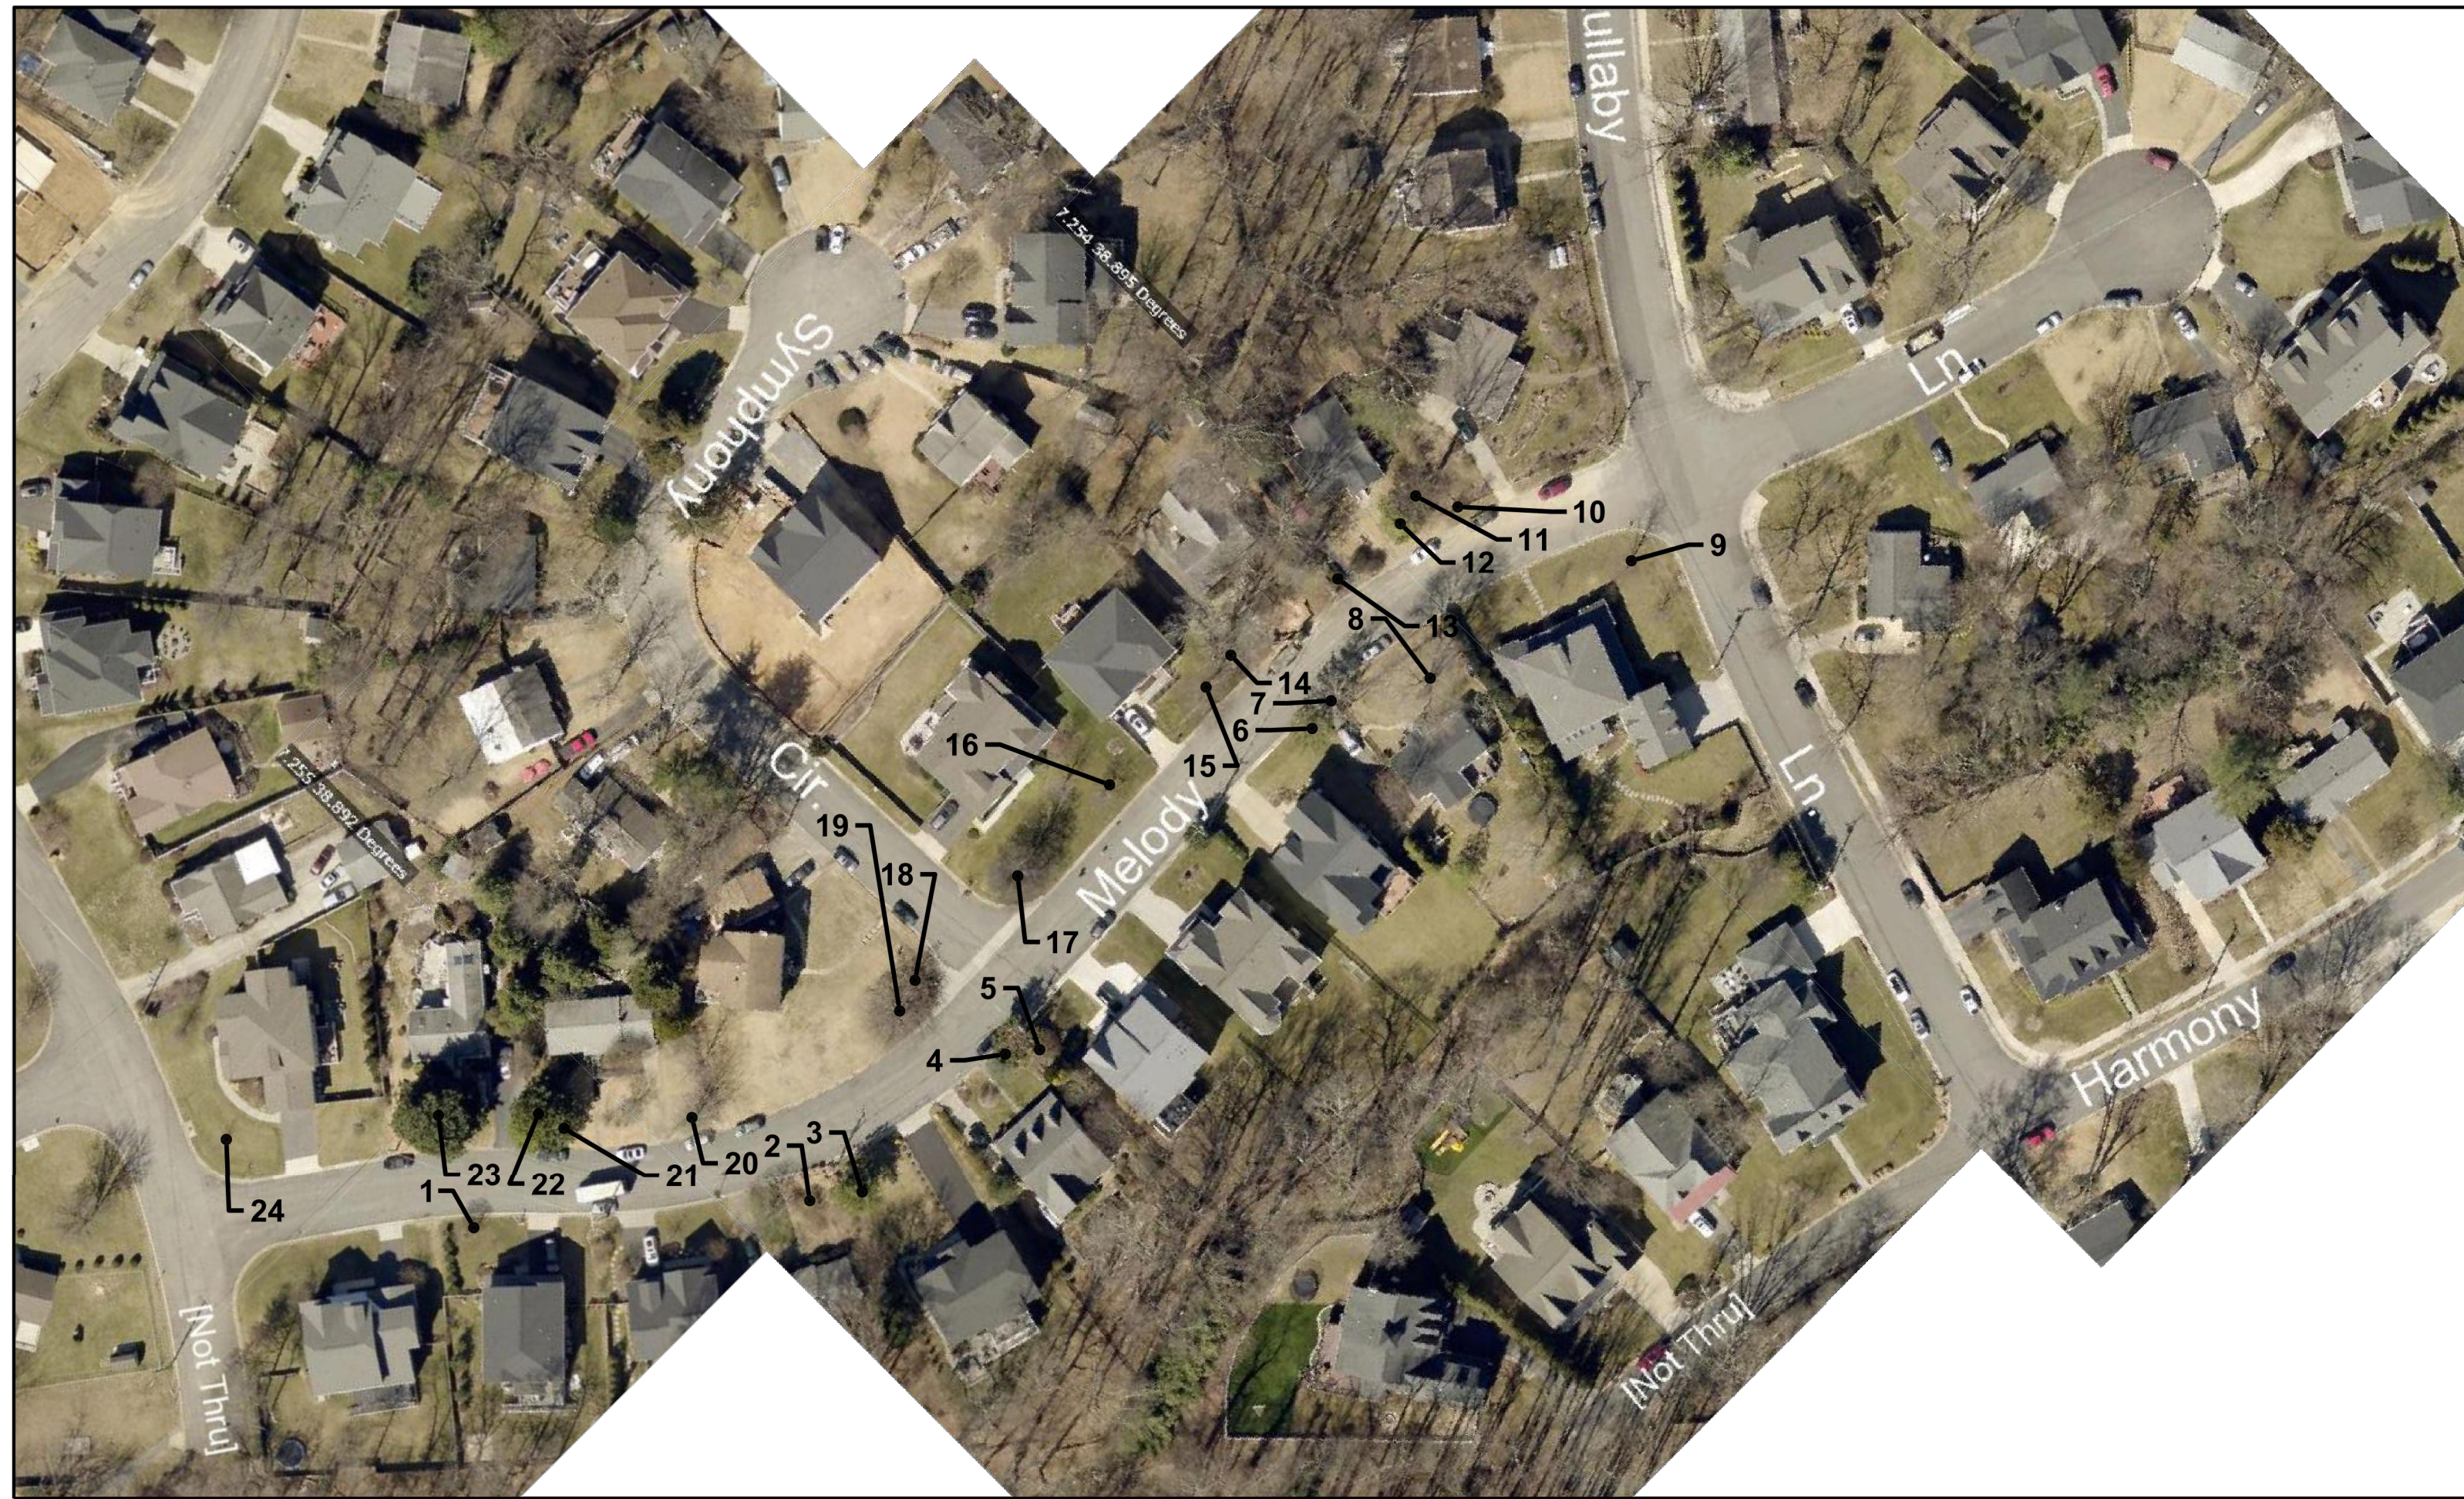
TREE LOCATIONS FOR INVENTORY  
BY URBAN - LTD 12/22/2021

Melody Ln. Vienna, VA										Tree Inventory and Condition Analysis Completed: 12/22/2021 Kevin J. Tankersley, ISA Certified Arborist #MA-5871A	
TREE INVENTORY & CONDITION ANALYSIS											
TREE NO.	SPECIES		SIZE	DRIP-LINE	CRITICAL ROOT ZONE	STRUCTURAL ROOT ZONE	CONDITION	CONDITION RATING	STATUS	COMMENTS	
	Botanical Name	Common Name	DBH (in)	R (ft.)	R (ft.)	R (ft.)		%	(Remove or Preserve)		
1	<i>Lagerstroemia indica</i>	Crape Myrtle	18"	8'	18'	9'	Good	75.00		Multi-stem; low branches which will need to be pruned. Grading in critical root zone will significantly impact tree.	
2	<i>Prunus yedoensis</i>	Yoshino Cherry	16"	12'	16'	8'	Excellent	81.25		Grading in critical root zone may impact tree.	
3	<i>Ilex opaca</i>	American Holly	22"	10'	22'	11'	Good	71.88		Co-dominant; behind power pole. May be kept if walk runs in front of pole towards curb.	
4	<i>Picea pungens</i>	Blue Spruce	14"	5'	14'	7'	Fair	56.25		Needle loss, tree is declining. In path of walk, tree would have to be removed.

12	<i>Ilex opaca</i>	American Holly	24"	10'	24'	12'	Fair	56.25		Multi-trunk; damage; decay at base. On slope; grading may impact critical root zone of tree.	
13	<i>Acer palmatum</i>	Japanese Maple	12"	10'	12'	6'	Good	75.00		In path of walk; tree would have to be removed.	
14	<i>Acer palmatum var. dissectum</i>	Weeping Japanese Maple	4"	4'	4'	2'	Excellent	84.38		In path of walk; tree would have to be removed.	
15	<i>Betula nigra</i>	River Birch	16"	12'	16'	8'	Good	75.00		Co-dominant. On slope, grading may impact critical and structural root zone.	
16	<i>Cornus florida</i>	Flowering Dogwood	10"	7'	10'	5'	Fair	56.25		On slope, critical and structural root zone will be impacted by grading. Low branches would need to be limbed up.	
17	<i>Pyrus calleryana</i>	Bradford Pear	20"	16'	20'	10'	Good	62.50		Tree exhibits stress growth. Critical root zone of tree would be affected.	
18	<i>Cornus florida</i>	Flowering Dogwood	6"	5'	6'	3'	Good	68.75		One-sided; Grading will impact

Melody Ln. Vienna, VA										Tree Inventory and Condition Analysis Completed: 12/22/2021 Kevin J. Tankersley, ISA Certified Arborist #MA-5871A	
TREE INVENTORY & CONDITION ANALYSIS											
TREE NO.	SPECIES		SIZE	DRIP-LINE	CRITICAL ROOT ZONE	STRUCTURAL ROOT ZONE	CONDITION	CONDITION RATING	STATUS	COMMENTS	
	Botanical Name	Common Name	DBH (in)	R (ft.)	R (ft.)	R (ft.)		%	(Remove or Preserve)		
19	<i>Prunus yedoensis</i>	Yoshino Cherry	26"	24'	26'	13'	Excellent	0.00		Low branches overhang street; would have to be limbed up. Critical root zone of tree would be affected.	
20	<i>Acer rubrum</i>	Red Maple	20"	26'	20'	10'	Good	62.50		Co-dominant; Branches overhanging street would need to be limbed up. Tree critical root zone would be significantly affected.	
21	<i>Magnolia grandiflora</i>	Southern Magnolia	28"	14'	28'	14'	Good	71.88		Co-dominant. Critical root zone affected, recommend walk at curb if possible.

22	<i>Ilex opaca</i>	American Holly	18"	10'	18'	9'	Good	68.75		Multi-trunk. Critical root zone affected; recommend walk at curb if possible.	
23	<i>Magnolia grandiflora</i>	Southern Magnolia	36"	20'	36'	18'	Good	68.75		Co-dominant. Tree is on slope; grading will affect critical root zone. Recommend walk at curb if possible to minimize impact.	
24	<i>Liquidambar styraciflua</i>	Sweetgum	4"	6'	4'	2'	Excellent	84.38		Young tree.
