CONCEPT 1
DESALE STREET SW
CONCEPT STUDY
TOWN OF VIENNA
FAIRFAX COUNTY, VIRGINIA
DATE: MAY, 2022
SCALE: 1"=30'
C.I. N/A

Tree Inventory and Condition Analysis
Completed: 12/22/2021
Kevin J. Tankersley, ISA Certified Arborist #MA-5871A

TREE INVENTORY & CONDITION ANALYSIS

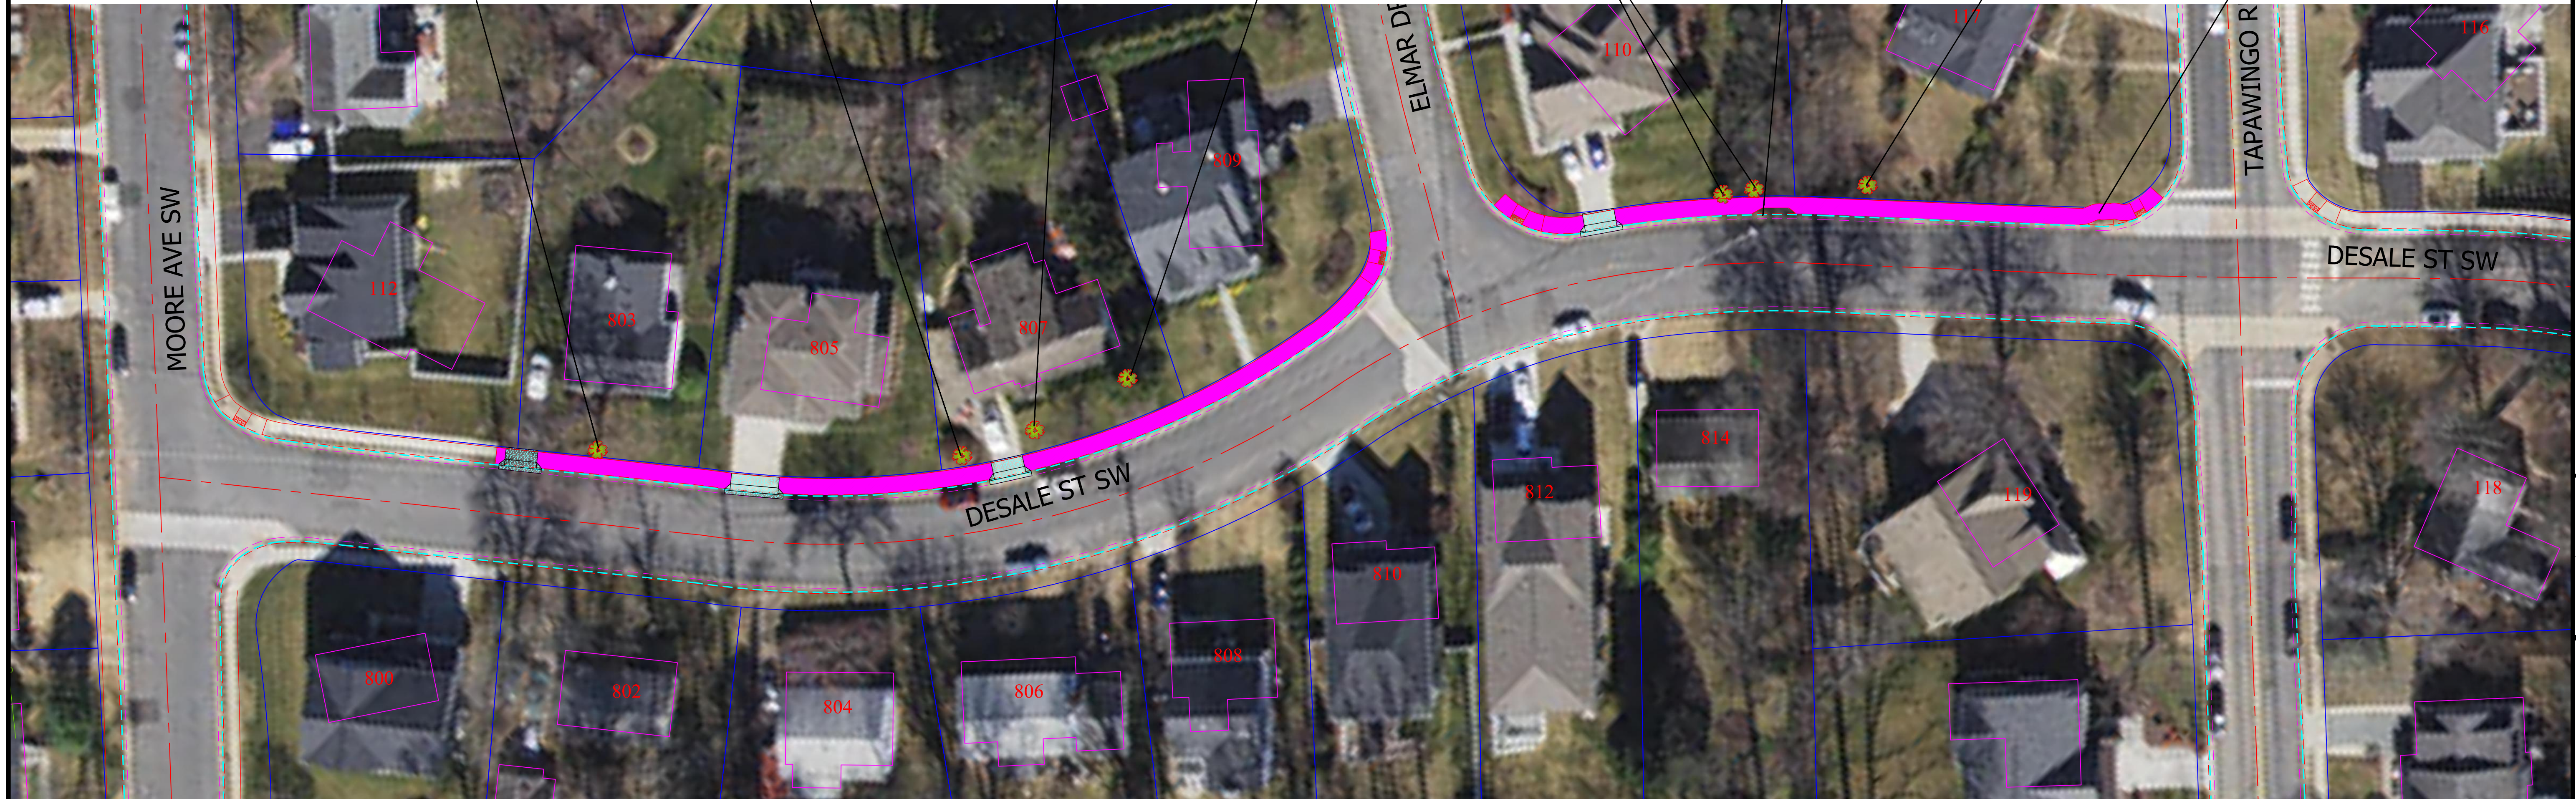
SHEET
1
OF
6
FILE No.
PP-2528

CONCEPT 1
SIDEWALK ALONG ODD SIDE ADDRESS OF DESALE ST SW. THE SIDEWALK WILL EXTEND FROM THE MOORE AVE SW INTERSECTION TO THE DEAD END OF DESALE ST SW. THE CONCEPT INCLUDES THE SIDEWALK AND ADA RAMPS AT EACH INTERSECTION AND PROVIDES CONNECTION WITH ELMAR DR SW, TAPAWINGO RD SW & MELODY LANE SW. THIS WILL ALLOW THE PEDESTRIAN ACCESS TO THE MOORE AVE SW, ELMAR DR SW, TAPAWINGO RD SW & MELODY LANE SW.

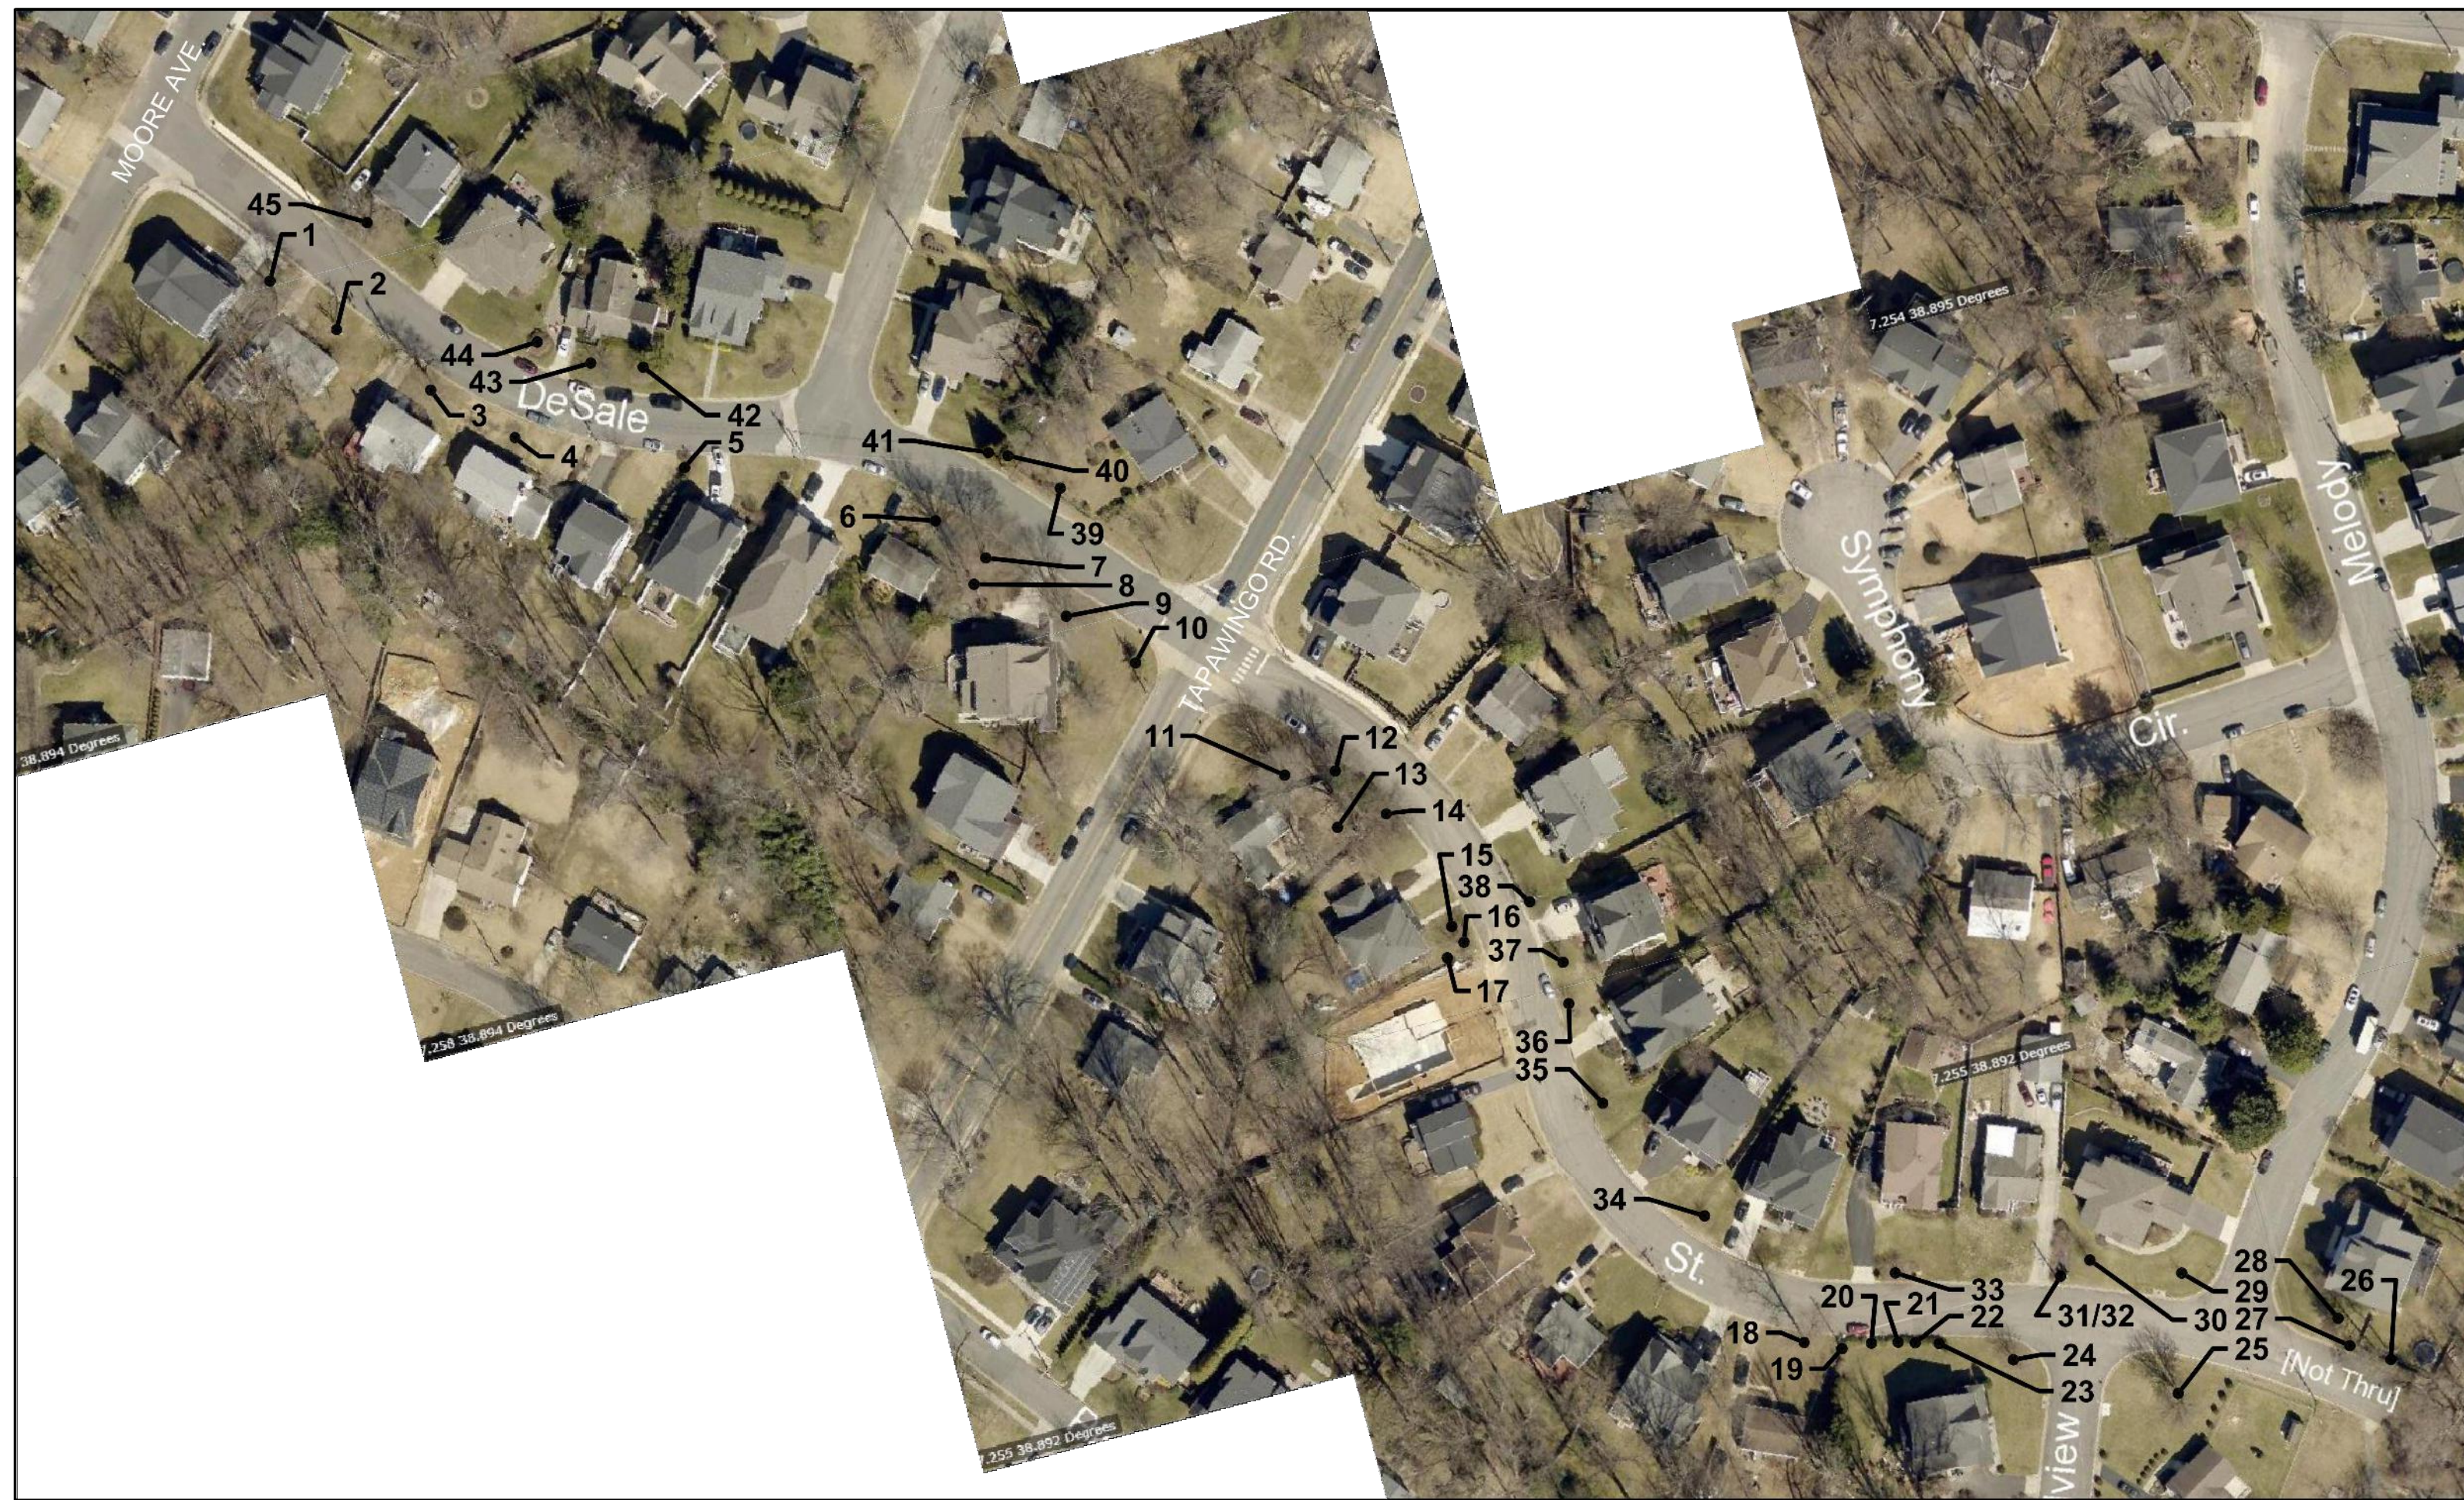
TREE LOCATIONS FOR INVENTORY BY URBAN - LTD 12/22/2021

TREE NO.	SPECIES		SIZE		CRITICAL ROOT ZONE	STRUCTURAL ROOT ZONE	CONDITION	CONDITION RATING	STATUS	COMMENTS
	Botanical Name	Common Name	DBH (in)	R (ft.)						
1	<i>Acer rubrum</i>	Red Maple	24"	20'	24'	12'	Good	68.75	(Remove or Preserve)	Slight lean; Co-dominant
2	<i>Acer rubrum</i>	Red Maple	24"	12'	24'	12'	Poor	34.38		Nearly dead; Significant decay; One-sided canopy
3	<i>Acer rubrum</i>	Red Maple	24"	16.0'	24'	12'	Good	68.75		Street side heavily pruned for power lines
4	<i>Cornus spp.</i>	Dogwood	10"	8'	10'	5'	Good	75.00		Multitrunk; low branches may need to be pruned for walk clearance.
5	<i>Prunus x yedoensis</i>	Yoshino Cherry	8"	8'	8'	4'	Good	75.00		In ROW
6	<i>Acer rubrum</i>	Red Maple	8"	4.0'	8'	4'	Good	68.75		Co-dominant; Severe V crotch
7	<i>Acer rubrum</i>	Red Maple	26"	26'	26'	13'	Good	62.50		Co-dominant; grading will impact critical root zone. Recommend locating walk at curb to minimize grading impacts.

8	<i>Liriodendron tulipifera</i>	Tulip Poplar	38"	20'	38'	19'	Excellent	87.50		Large tree with extensive critical root zone.
9	<i>Acer rubrum</i>	Red Maple	32"	22.0'	32'	16'	Fair	50.00		Trunk decay; multi-trunk with poor structure.
10	<i>Cedrus deodara</i>	Deodar Cedar	6"	7'	6'	3'	Good	71.88		Young tree. On slope; grading will impact critical root zone.
11	<i>Acer palmatum</i>	Japanese Maple	30"	10'	30'	15'	Fair	43.75		Significant trunk decay, low branches; dieback; multi-trunk.
12	<i>Acer rubrum</i>	Red Maple	20"	12.0'	20'	10'	Good	75.00		Walk will likely impact the structural root zone.
13	<i>Liriodendron tulipifera</i>	Tulip Poplar	46"	35'	46'	23'	Good	71.88		Very large co-dominant with extensive critical root zone.
14	<i>Acer rubrum</i>	Red Maple	16"	12'	16'	8'	Fair	50.00		Leaning over; multi-trunk. Very close to walkway location, probably severe impacts to critical root zone.
15	<i>Prunus pendula</i>	Weeping Cherry	6"	6.0'	6'	3'	Good	62.50		Trunk decay; tree in path of walk, would need to be removed.

TREE NO.	SPECIES		SIZE		CRITICAL ROOT ZONE	STRUCTURAL ROOT ZONE	CONDITION	CONDITION RATING	STATUS	COMMENTS
	Botanical Name	Common Name	DBH (in)	R (ft.)						
20	<i>Cornus kousa</i>	Kousa Dogwood	4"	4'	4'	2'	Excellent	84.38		Tree in ROW in path of walk; would have to be removed.
21	<i>Cornus kousa</i>	Kousa Dogwood	3"	3.0'	3'	2'	Good	75.00		Tree in ROW in path of walk; would have to be removed.
22	<i>Cornus kousa</i>	Kousa Dogwood	3"	3'	3'	2'	Good	75.00		Tree in ROW in path of walk; would have to be removed.
23	<i>Cornus florida</i>	Flowering Dogwood	2"	2'	2'	1'	Good	75.00		Tree in ROW in path of walk; would have to be removed.
24	<i>Acer rubrum</i>	Red Maple	11"	14.0'	11'	6'	Excellent	81.25		Tree on slope; grading would impact critical root zone.
25	<i>Acer rubrum</i>	Red Maple	14"	18'	14'	7'	Good	65.63		Far back OK
26	<i>Liquidambar styraciflua</i>	Tulip Poplar	13"	4.0'	13'	7'	Fair	37.50		Poor; suffering from construction damage.
