FILE No. RP-2532

ANALYSIS OF CONCEPT 1- TAZEWELL RD NW

TREE INVENTORY & CONDITION ANALYSIS

TAZEWELL ROAD NW
SIDEWALK STUDY
TOWN OF VIENNA
FAIRFAX COUNTY, VIRGINIA

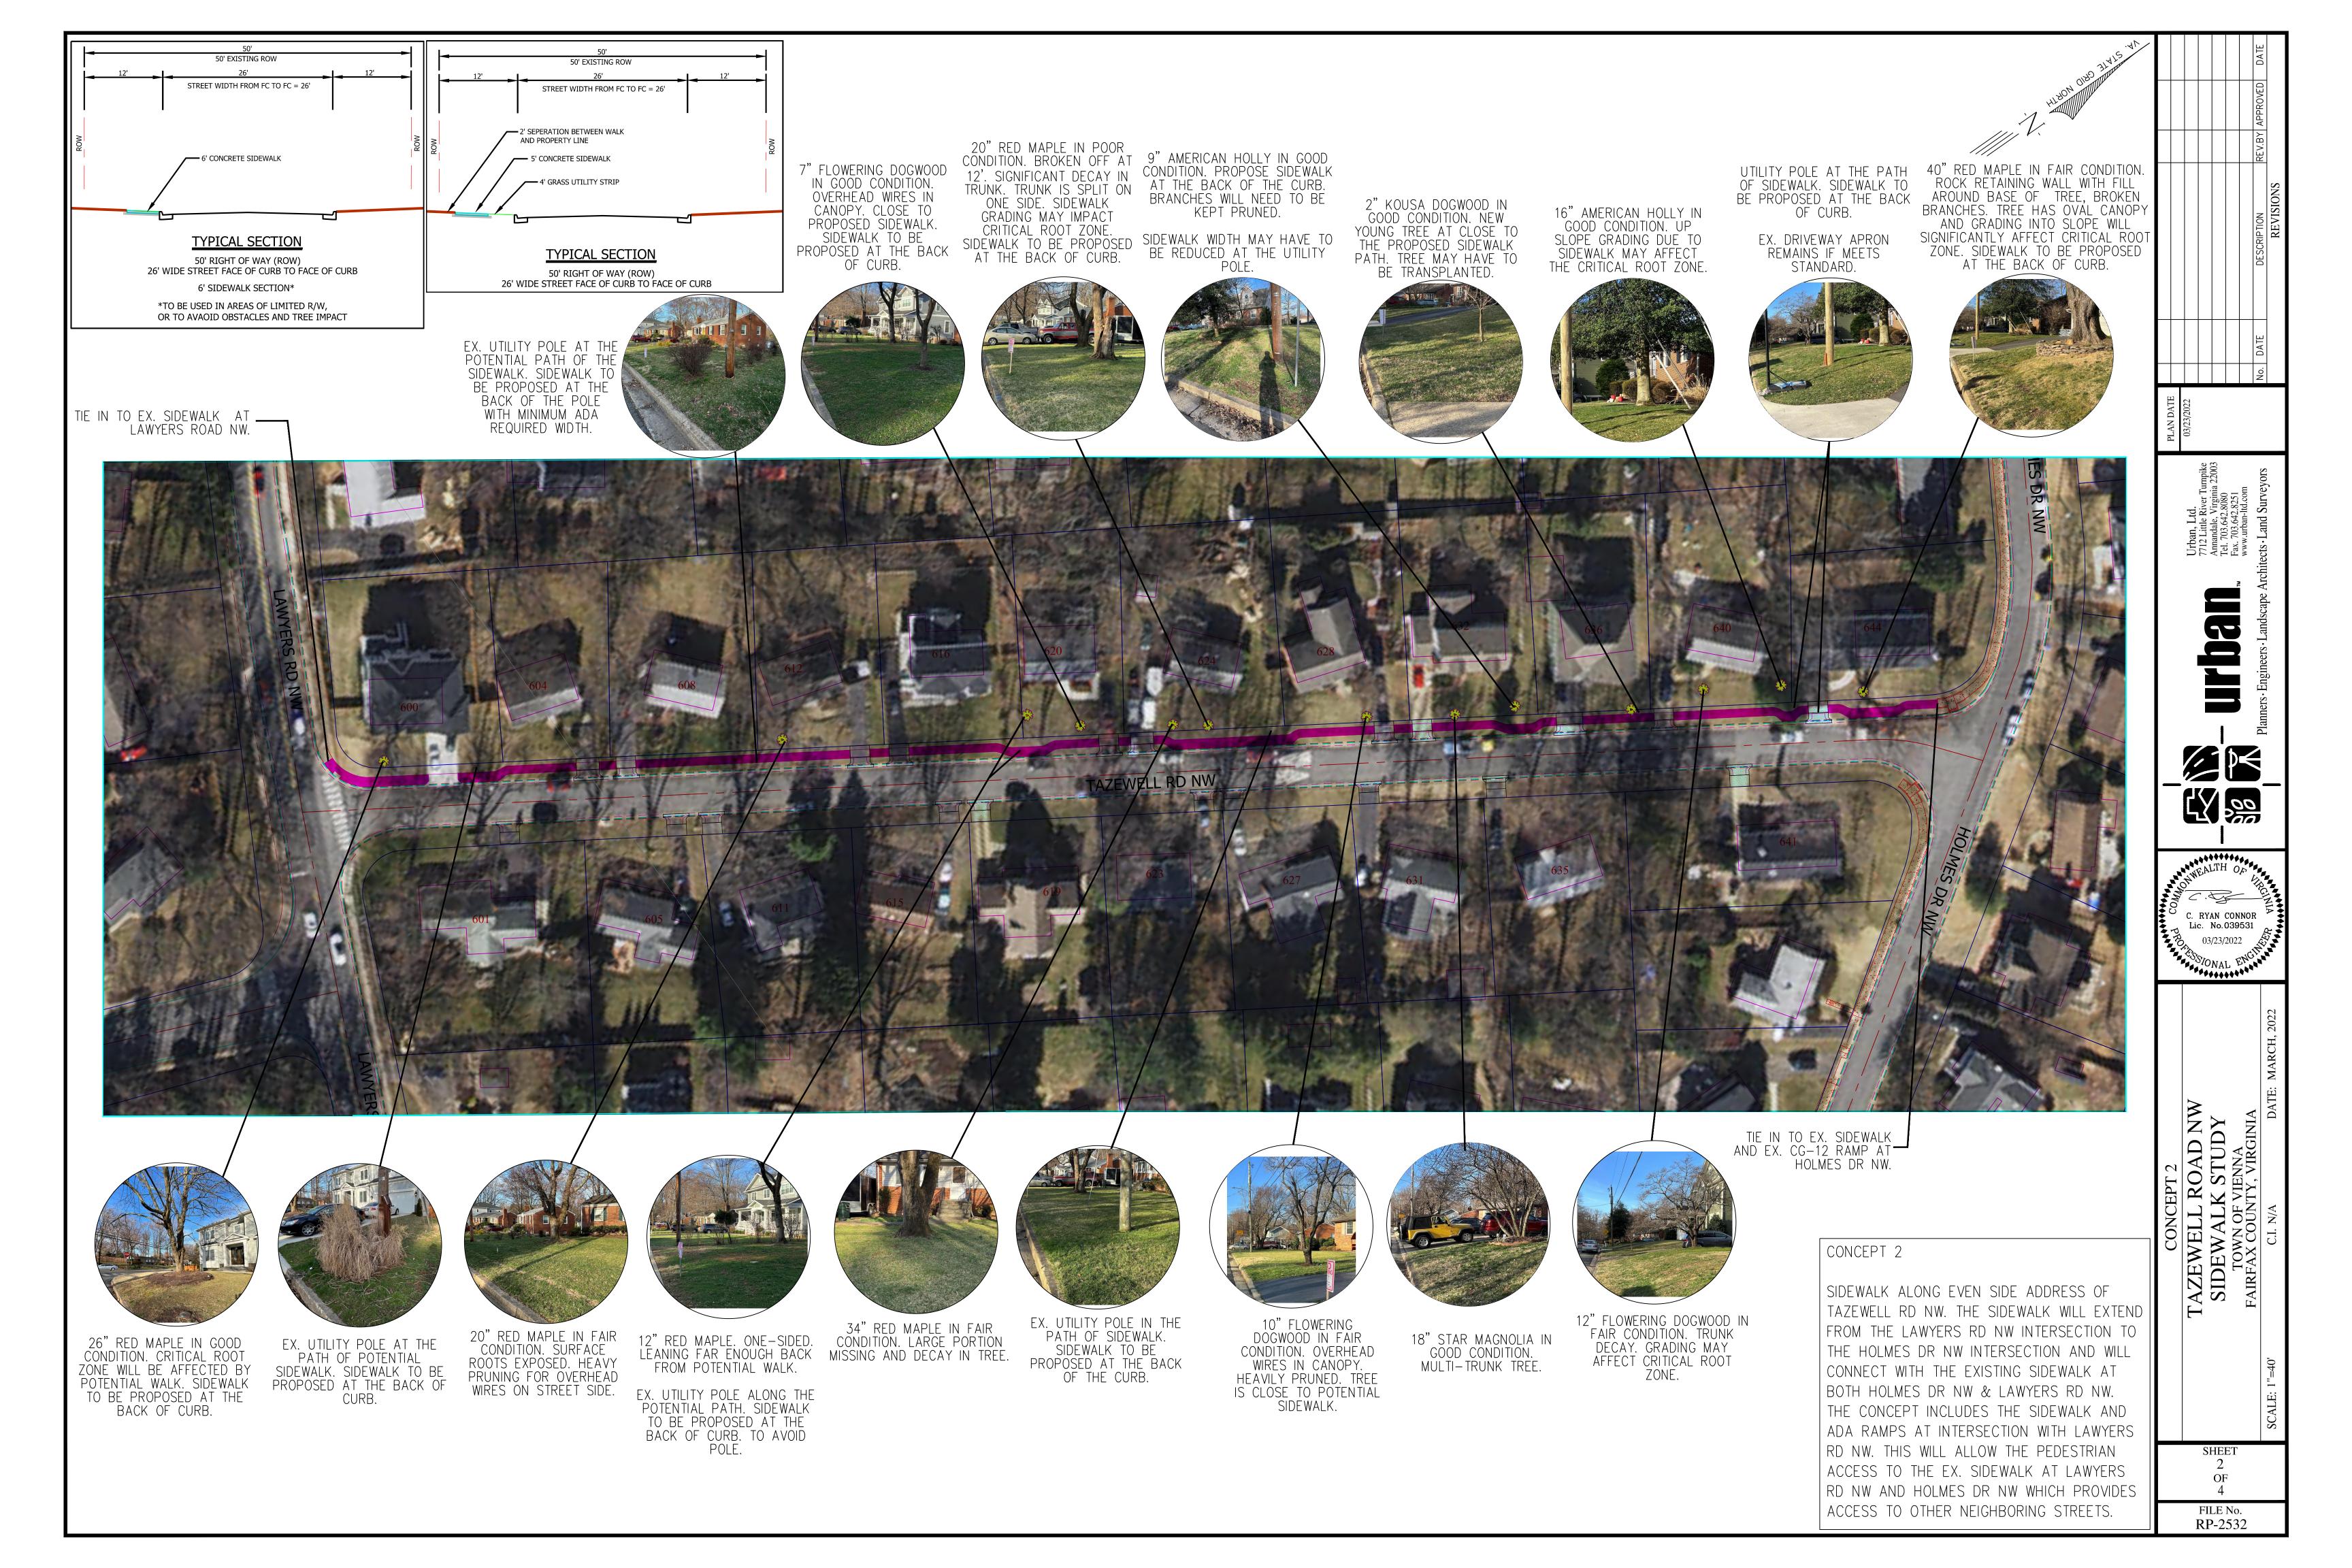
ANALYSIS OF CONCEPT 2- TAZEWELL RD NW

TREE IMPACT	OVERALL, TREES ALONG THIS SIDE OF THE STREET ARE IN FAIR TO EXCELLENT CONDITION. WITH CONCEPT ONE, AT LEAST TWO TREES WILL NEED TO BE REMOVED AND TWO TREES CAN BE TRANSPLANTED. THIRTEEN ADDITIONAL TREES MAY BE AFFECTED TO VARYING DEGREES BY GRADING INTO THEIR CRITICAL ROOT ZONES DUE TO THEIR UPSLOPE POSITION RELATIVE TO THE PROPOSED SIDEWALK LOCATION. IN SOME CASES THE WALK IS POSITIONED AT THE BACK OF THE CURB TO MITIGATE THE EFFECTS FROM THE GRADING.	FOUR TREES WILL NEED TO BE REMOVED INCLUDING THE TWO LARGE RED MAPLES AT EITHER END OF THE STREET TO IMPLEMENT THE CONCEPT 2 SIDEWALK. AN ADDITIONAL TWO TREES WILL BE AFFECTED BY GRADING INTO THEIR CRITICAL ROOT ZONES. OVERALL, THE TREES ALONG THIS SIDE OF THE STREET ARE IN POOR TO FAIR CONDITION, WITH MANY OF THEM HAVING SIGNIFICANT HEALTH AND STRUCTURAL ISSUES.						
IMPACTS ON VEGETATION (OTHER THAN TREES)	THERE ARE MINIMAL IMPACTS TO OTHER VEGETATION BY THIS CONSTRUCTION. THIS ANALYSIS IS FOCUSED MORE ON THE POTENTIAL CONSTRUCTION IMPACTS TO LARGER TREES. IF THIS CONCEPT IS PURSUED REPLACEMENT VEGETATION AND POSSIBLY TRANSPLANTATION OF PLANTS/ SHRUBS WILL BE CONSIDERED.	THERE ARE MINIMAL IMPACTS TO OTHER VEGETATION BY THIS CONSTRUCTION. THIS ANALYSIS IS FOCUSED MORE ON THE POTENTIAL CONSTRUCTION IMPACTS TO LARGER TREES. IF THIS CONCEPT IS PURSUED REPLACEMENT VEGETATION AND POSSIBLY TRANSPLANTATION OF PLANTS/ SHRUBS WILL BE CONSIDERED.
